STRUCTURAL REPAIR OF HEAVILY DAMAGED REINFORCED CONCRETE  
COLUMNS: EXPERIMENTAL AND NUMERICAL STUDY

A THESIS SUBMITTED FOR  
THE DEGREE OF ASSOCIATE PROFESSOR

2023

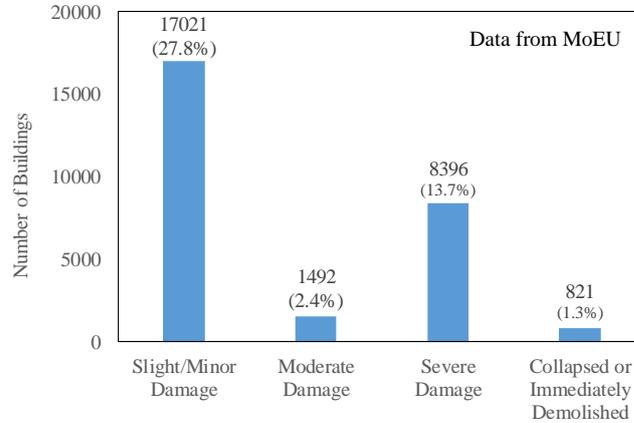
Fig. 1.1. Damage distribution among the investigated 61152 buildings by February 08, 2020 (Yurdakul et al. 2021).

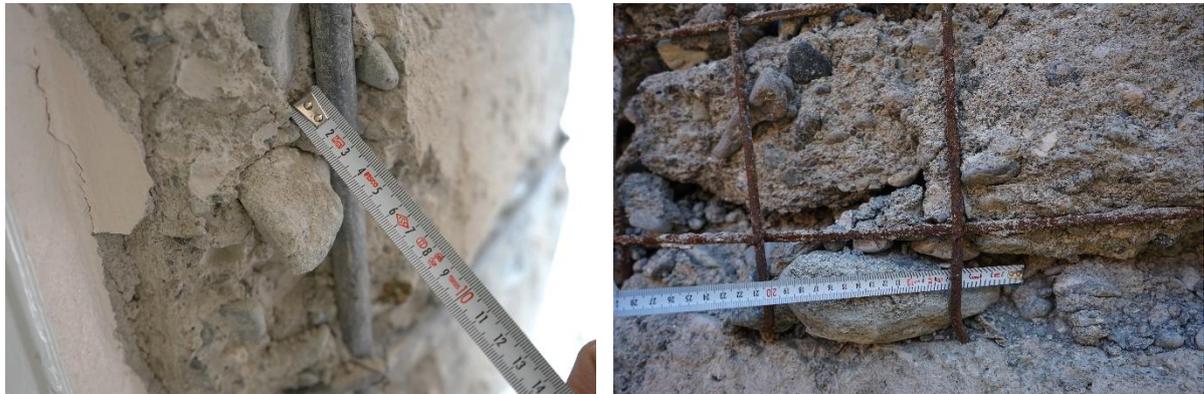
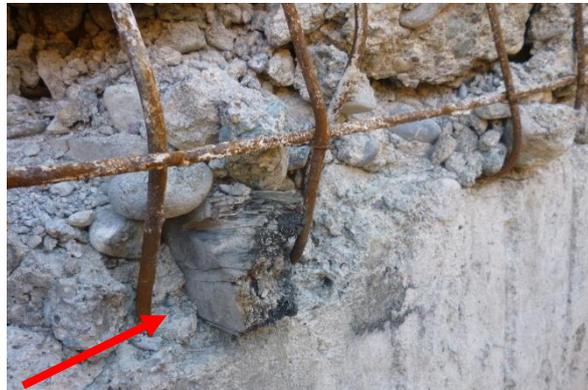
Fig. 1.2. (a) Aggregate size in slightly/moderately damaged buildings (b) organic material in concrete (Yurdakul et al. 2021).

improper aggregate size and type (Fig. 1.2a), and organic materials in the concrete (Fig. 1.2b) (Yurdakul et al. 2021).

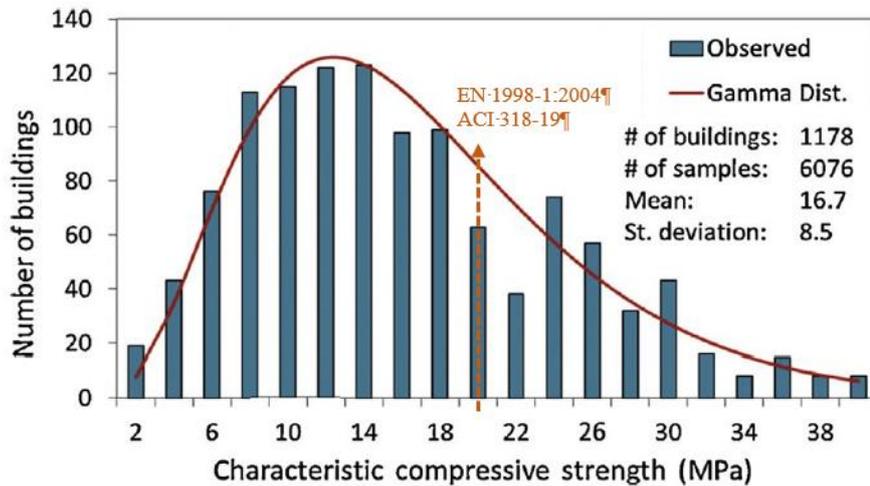
Fig. 1.3. Concrete strength distribution in İstanbul and surrounding cities (Bal et al. 2008) and comparison with the minimum code requirements.

Bal *et al.* (2008) found the mean value of compressive strength as 16.73 MPa in existing RC Buildings in İstanbul, Turkey (Fig. 1.3). A more dramatic concrete compressive strength value (10.35 MPa) was reported in a collapsed building in Ceyhan, Turkey (Çağatay 2005). Mazılıgüney *et al.* (2008) analyzed the compressive strength of 4647 core specimens taken from 693 buildings in Istanbul, Turkey. The resulting mean value was 10.64 MPa, which also supports the other findings. After inspecting the RC buildings of Elazığ province in 2020 after the earthquake, the Turkish Ready Mixed Concrete Association (TRMCA 2020) reported the mean compressive strength between 6-12 MPa. Arslan and Korkmaz (2007) concluded that the average concrete compressive strength that was taken from damaged and undamaged buildings was as low as 1/3 of the design strengths. Del Vecchio *et al.* (2018) reported the average compressive strength of concrete as 11.92 MPa in a building demolished after the L'Aquila Earthquake, Italy. Masi and Vona (2009) worked on 824 concrete core samples in more than 200 RC buildings in Italy and found an average compressive strength of 12–16 MPa in 93 of

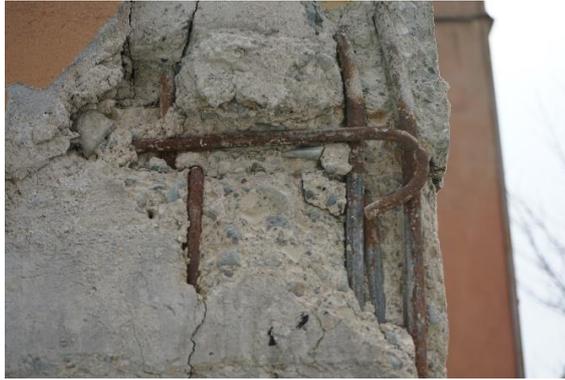
Fig. 1.4. RC member with plain round bar (Yurdakul et al. 2021).

The use of plain round bars could exhibit a poor bond performance as the other types of failures are usually preceded by bond-slip failure (Fig. 1.4). Therefore, structures with plain round bars are usually considered to be substandard with respect to today's construction practices. In these structures, the required level of interaction between concrete and a reinforcing bar could not be ensured, which results in bond-slip failure together with anchorage pull-out failure (Bull et al. 2009). The cohesion between reinforcing steel and concrete can be easily influenced by other factors such as concrete mechanical properties, level of confinement, clear cover, casting position, and geometric details (i.e., bar size and spacing) (ACI 408R-03 2003; Murcia-Delso 2013). The increase in the slump due to a high water-cement ratio, which is quite common for low-strength concrete, adversely affects the bond response, as well.

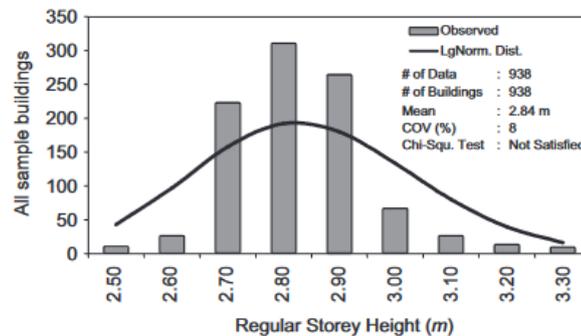
Fig. 1.5. Distribution of regular-story height for all RC buildings (Bal et al. 2008).

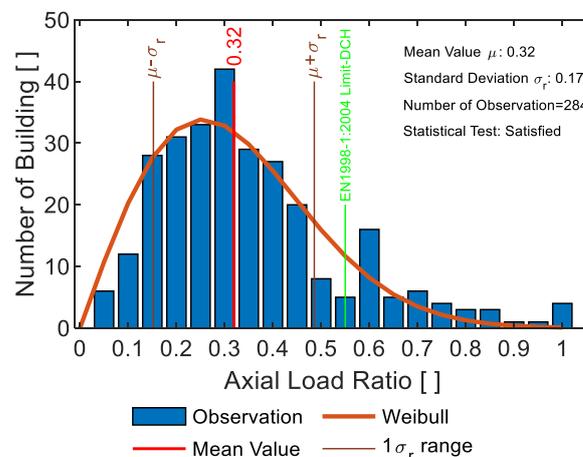
Fig. 1.6. Axial load distribution.

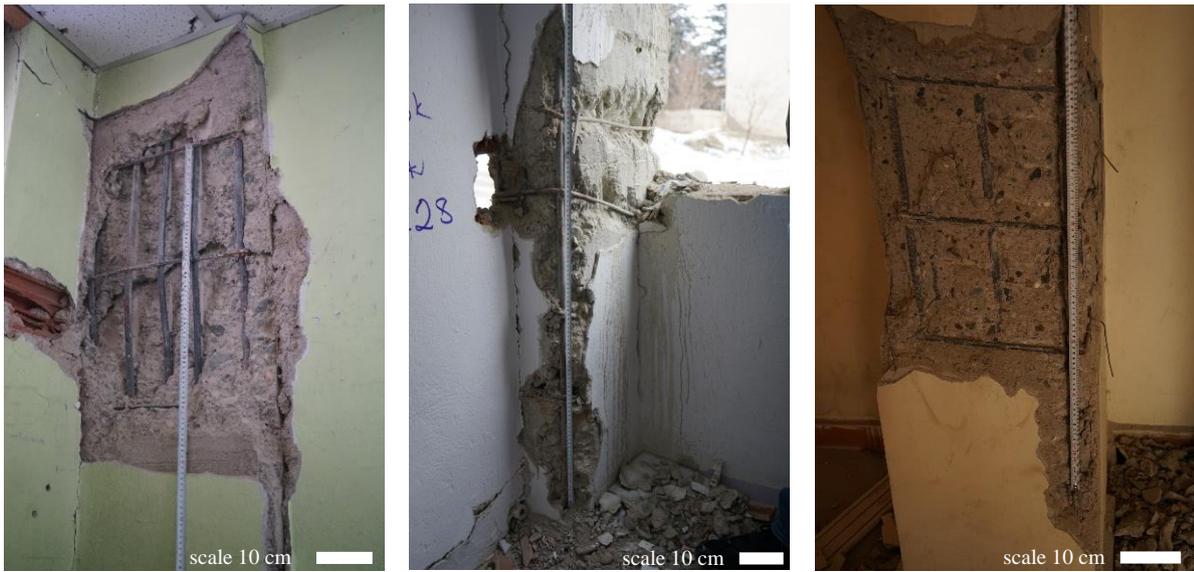
Fig. 1.7. Insufficient confinement-data from (a) Yurdakul *et al.* (2021) (b) Ricci *et al.* (2011).

The reconnaissance on the inspected RC members has shown no or low-level of confinement at member-ends. The spacing of the transverse reinforcement was measured around 25-30 cm in a non-uniform fashion in many of the inspected buildings, which is well above the accepted limits (Fig. 1.7a and b). The large spacing of transverse reinforcement has resulted in an increased unsupported length of longitudinal bars and hence less buckling resistance. Moreover, the inadequate number of stirrups with improper detailing reduced the beam-column joint shear capacity. As a result, shear cracks were observed in several inspected RC buildings. Devastating shear failure of the beam-column joints was reported in L'Aquila 2009 earthquake, Italy by Ricci *et al.* (2011). The main reason is the lack of shear reinforcement.

The spacing of the transverse reinforcement is measured around 25-30 cm in a non-uniform fashion in many of the inspected buildings, which is well above the accepted limits (Fig. 1.7a and b). Under-designed columns lead the premature shear damage, which can be followed by axial failure of the column. Note that the large spacing of transverse reinforcement has resulted in an increased unsupported length of longitudinal bars, and hence less buckling resistance. Besides, the complete opening of hoops, together with the lack of cross ties, decrease the buckling resistance of the reinforcement. The use of low-strength concrete leads to the crushing of concrete. As a result, the axial-load-bearing capacity of the RC column is lost (Fig. 1.15a-d).

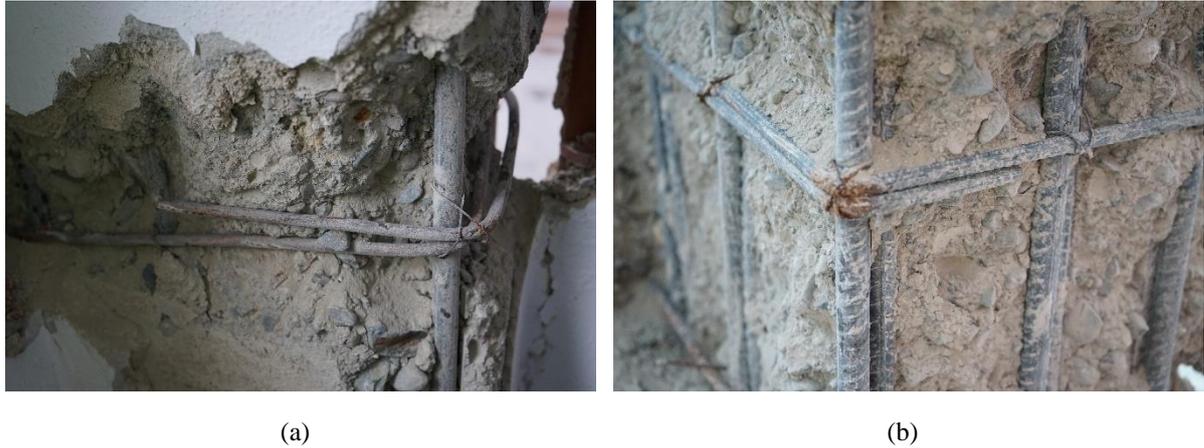
Fig. 1.8. Hook details of seismic hoops in column (a) plain round bars (b) deformed bars (Yurdakul et al. 2021).

Special seismic hoops and cross ties shall be provided for RC sections in all seismic zones. According to EN1998-1:2004 (CEN 2004b), the seismic hoops should have  $135^\circ$  hooks with  $10d_{bw}$  anchorage length at both ends, where  $d_{bw}$  is the stirrup diameter. However, those were not provided in the reported studies (Fig. 1.8a and b). The stirrups were bent improperly with  $90^\circ$  hooks, which is non-conforming even with the current and former standards.

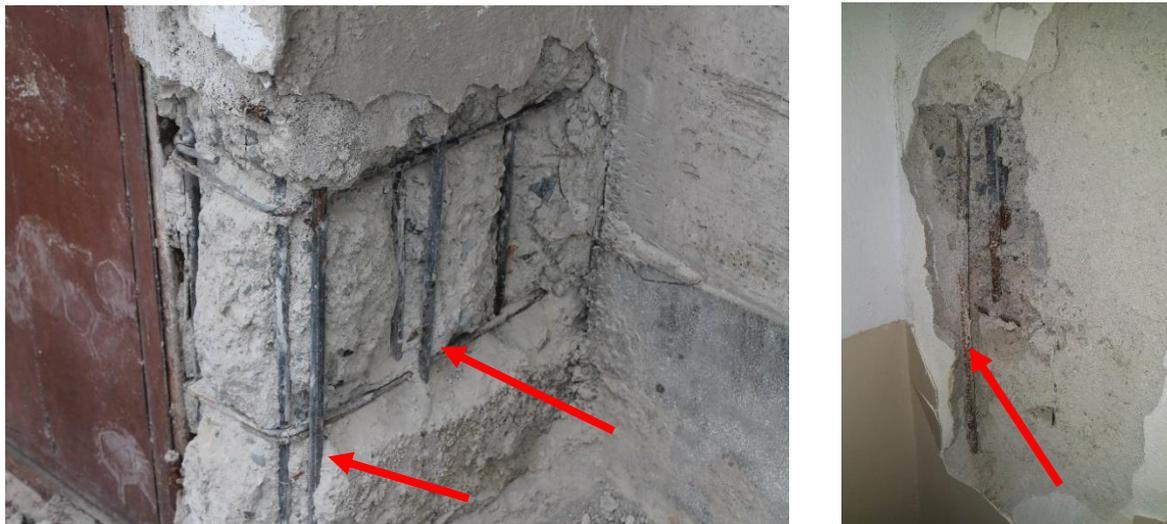
Fig. 1.9. Unengaged longitudinal bar (Yurdakul et al. 2021).

The stirrups should engage the longitudinal reinforcement from the outside (EN1998-1:2004 (CEN 2004b)). Both hooks of the stirrups shall be closed around the same longitudinal bar. On the other hand, as an example of poor workmanship in the reported column members, some of the column longitudinal bars were out of the confined region, which could possibly cause reinforcement buckling (Fig. 1.9).

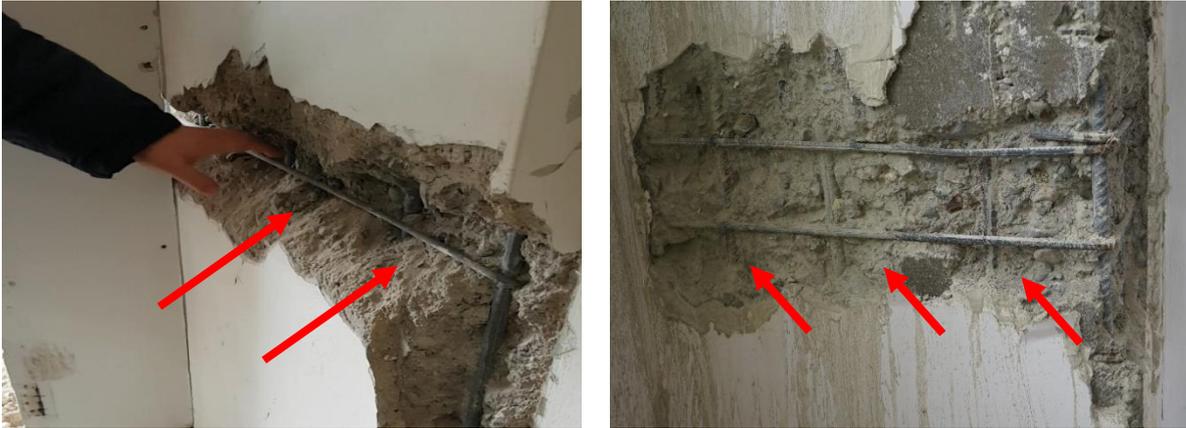
Fig. 1.10. Reinforcing detail without cross-ties (Yurdakul et al. 2021).

Providing crossties with proper spacing links the column longitudinal bars at opposite sides, which increases the buckling resistance of the longitudinal bars, and thereby prevents the opening of the stirrups. This is one of the most critical detailing requirements for the transverse reinforcement in providing the integrity of the RC column sections. Without the presence of crossties, it is almost not possible to restrain the longitudinal bars with the flexural stiffness of perimeter hoops only. The arrangement of crossties arranged in the columns was also enforced in EN1998-1:2004 (CEN 2004b). On the other hand, the code requirements were not fulfilled in many of the reported buildings (Fig. 1.10).

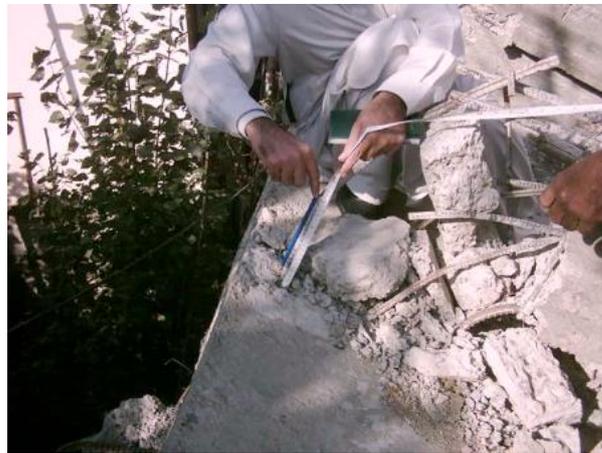
Fig. 1.11. Reported lap splice failure by Naseer *et al.* (2010).

The assumption of the perfect bond between the concrete and reinforcement bar is one of the most fundamental assumptions. The use of plain round bars in many buildings constructed in the 70s cannot or can barely satisfy the required level of interaction. Besides, the necessary hook details (i.e.,  $180^\circ$ ) at the end of the members with the required overlapping distance shall be provided for plain round bars. On the other hand, non-seismically designed and detailed RC buildings lack such important criteria (Fig. 1.11).

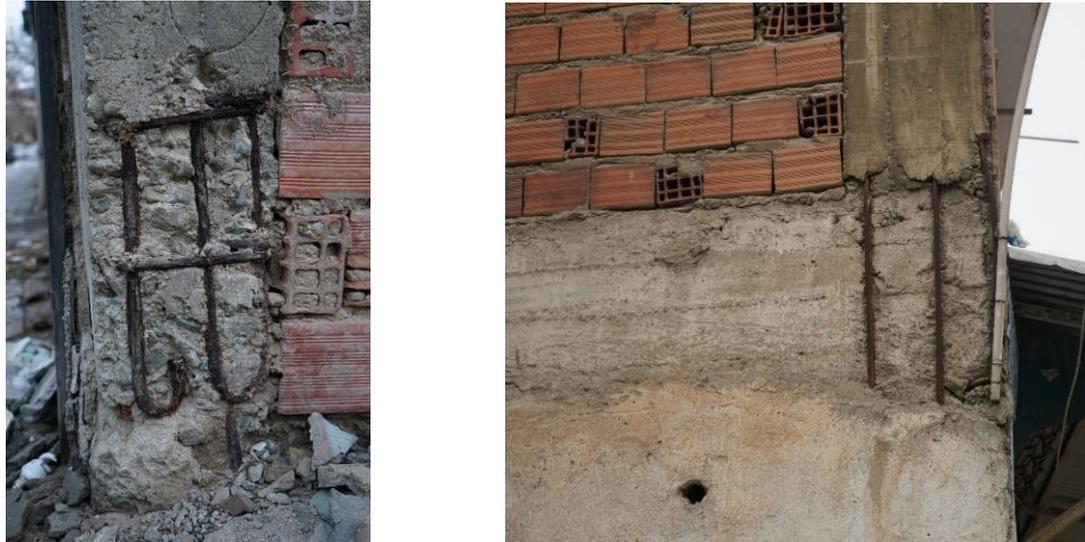
Fig. 1.12. Corroded reinforcement (Yurdakul et al. 2021).

The bond mechanism is violated not only by detailing issues but also by corrosion. Insufficient concrete cover and harsh environmental conditions accelerated the corrosion mechanism, which actuates the corrosion-induced cracks in concrete. Those, as a side effect, result in the loss of interaction between concrete and reinforcing steel, and diameter decrement in the bar (Fig. 1.12).

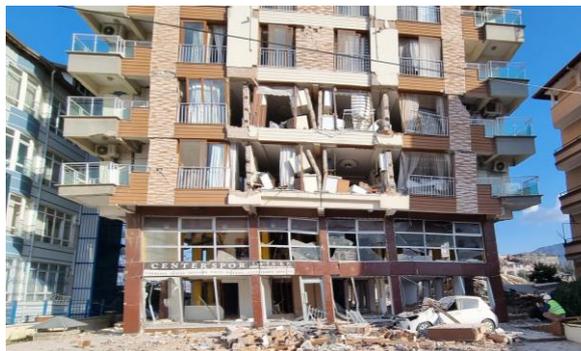
Fig. 1.13. Soft story induced damage in Maraş Earthquake 2023 (Photo Credit: Yunus Demirtaş)

A very typical design practice in the conventional building stock of Mediterranean countries is to have commercial units on the ground floor with either larger openings in the infill walls or without any infill walls. Ground story height is usually higher than the normal stories used for residential purposes. The soft stories are usually designed as a shop, parking garage, or storage purposes. On the other hand, the stiffness provided by the infill walls reduces the deformation in the upper stories, while the elimination of infill walls causes more lateral deformation in the ground story. The increased column deformations localized at the ground level are not foreseen in the design stage if the effect of infill walls is not considered in the structural analysis. This may cause local damage or even total collapse of the structure due to the formation of the soft-story mechanism. Moreover, non-structural components at the ground story suffer from more damage due to larger inter-story drift demands (Fig. 1.13).

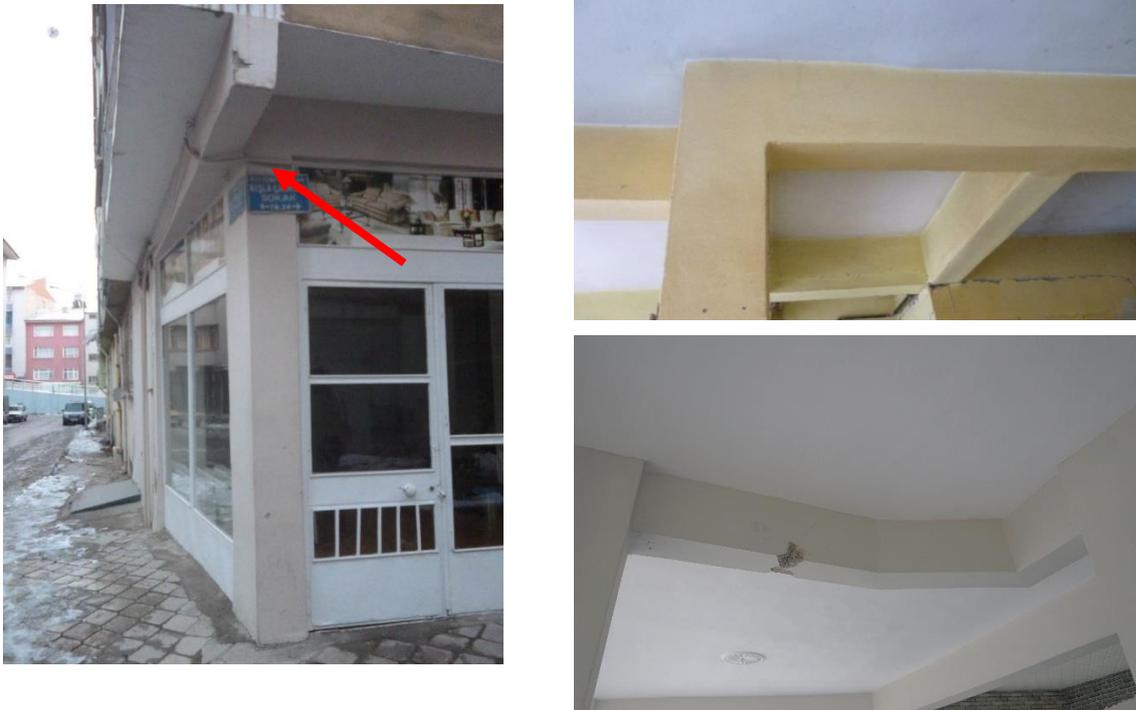
Fig. 1.14. Frame discontinuity (Yurdakul et al. 2021).

The frame irregularity is characterized by discontinuities in the vertical or horizontal directions, which adversely affects the performance of buildings. Several types of frame irregularities are found in some of the reported buildings, which were graded as moderately damaged buildings (Fig. 1.14). To transfer the inertial forces, mainly developed at the floor level from floors to the ground, the frame components should be continuously connected to each other from their geometric axis as much as possible. However, numerous frame discontinuity examples were reported (Yurdakul et al. 2021).

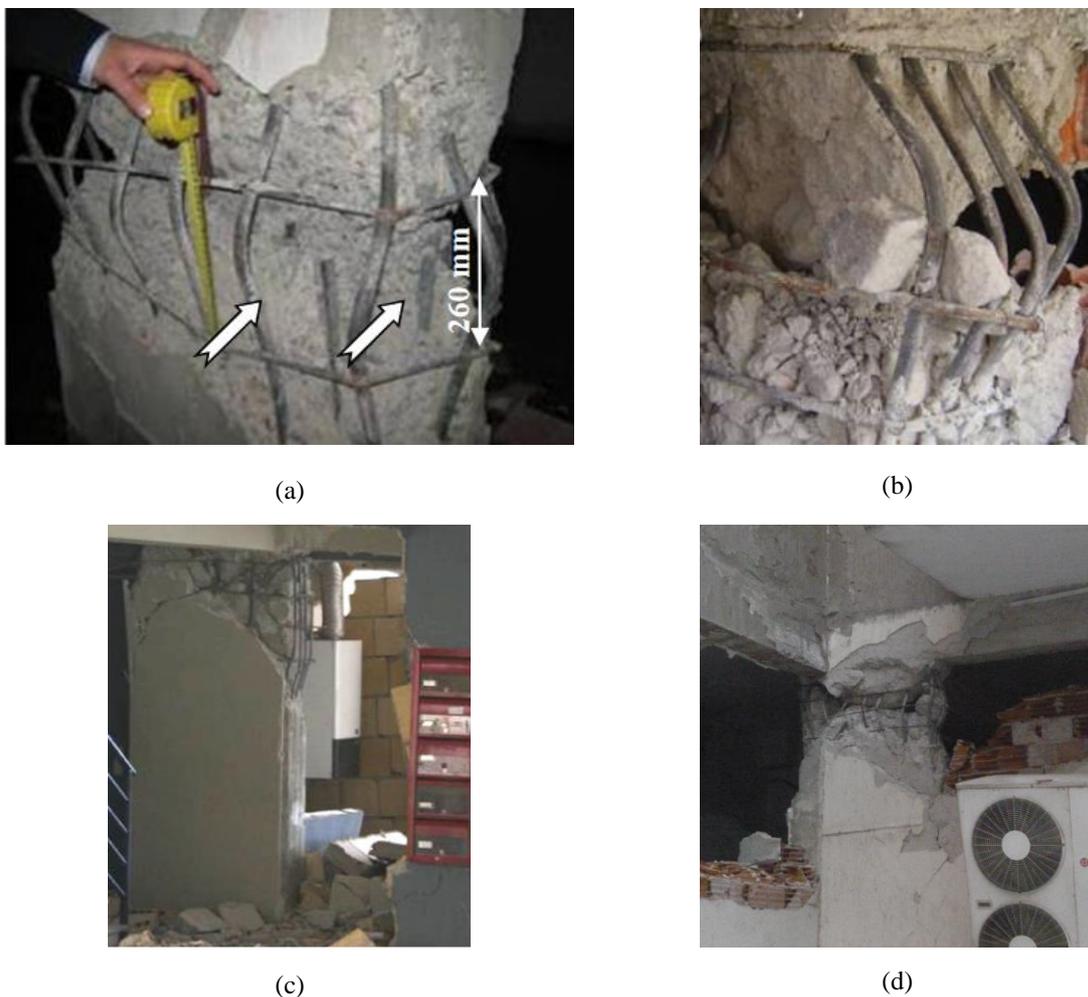
Fig. 1.15. Column axial failure (a) Van 2011 earthquake, Turkey (Öztürk 2015) (b) Kütahya-Simav 2011 earthquake (Yılmaz and Avşar 2013) (c) L'Aquila 2009 earthquake, Italy (Ricci et al. 2011) (d) İzmir Seferihisar 2020 earthquake, Turkey (Photo Credit: Özgür Avşar).

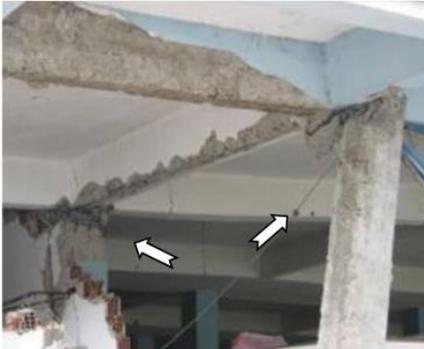
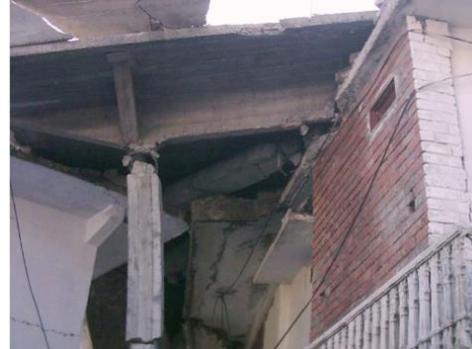
Fig. 1.16. Strong beam-weak column failure (a) Van 2011 earthquake, Turkey (Öztürk 2015) (b) Kashmir 2005 earthquake, Pakistan (Naseer et al. 2010).

the beam end. In many cases, this phenomenon is violated due to deep/strong beams connected to weak/flexible columns. The plastic hinge forms in the column end, which can result in severe damage or even loss of stability (Fig. 1.16a and b).

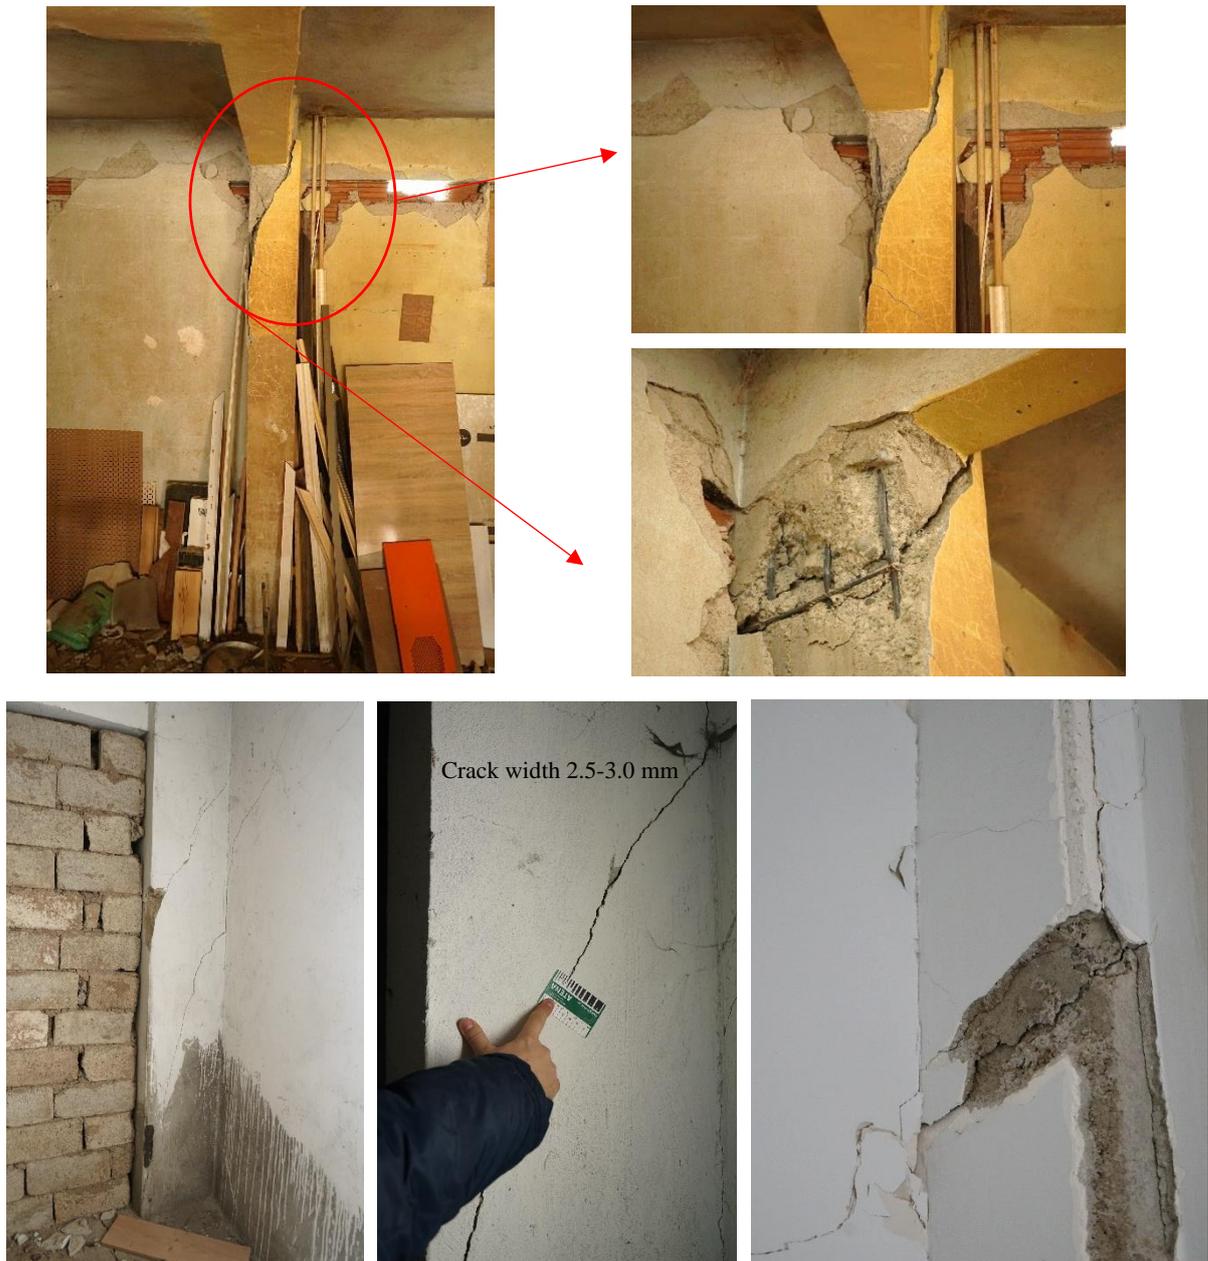
Fig. 1.18. Column shear damage (Yurdakul et al. 2021).

Some of the columns with improper detailing could not resist the large shear demand and attained their shear capacity, causing visible shear cracks on the columns and brittle type of column shear damage (Fig. 1.18). The large stirrup spacing decreased the shear capacity of the columns. In addition, the low-strength concrete has contributed to the shear cracks developed on the columns. Moreover, the aggregate interlock mechanism, one of the primary sources of concrete shear strength, is not sufficient due to the improper gradation of aggregates. Overall, the shear cracks took place at the column members as a result of several deficiencies.

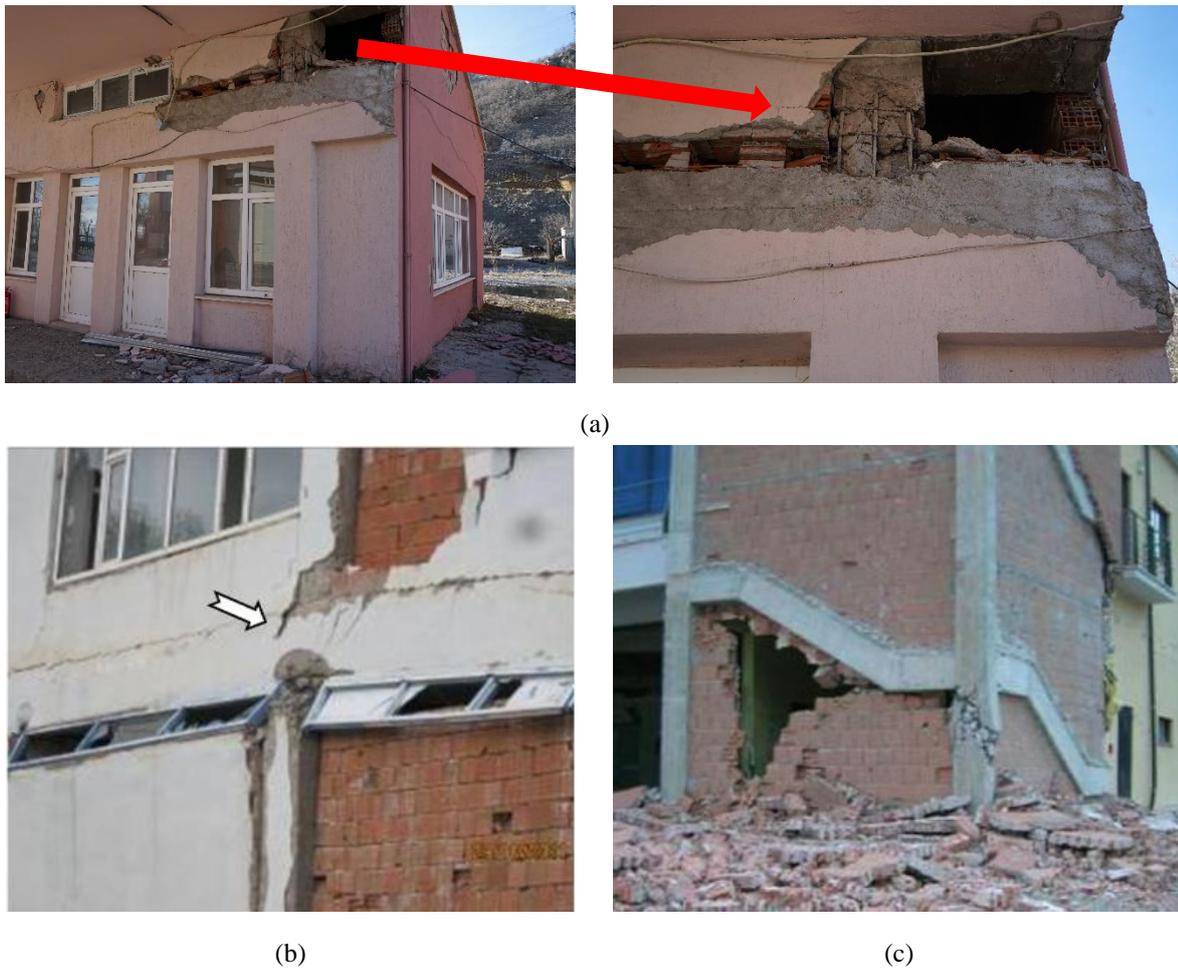
Fig. 1.19. Short column due to structural element (a) Elazığ 2020 earthquake, Turkey (Yurdakul et al. 2021) (b) Van 2011 earthquake, Turkey (Öztürk 2015) (c) L'Aquila 2009 earthquake, Italy (Ricci et al. 2011).

In many cases, the effective height of the column can be much less than the story height. The reduction in the column's effective height can be due to the structural and non-structural restrictions of the lateral displacement of the columns. The stiffness of such columns increases considerably in proportional to the reduction of column effective height, resulting in an excessive increase in the column shear demand during seismic excitation. When the short column phenomenon is combined with the substandard RC column detailing, the column shear failure is unavoidable, as seen in Fig. 1.19a-c.

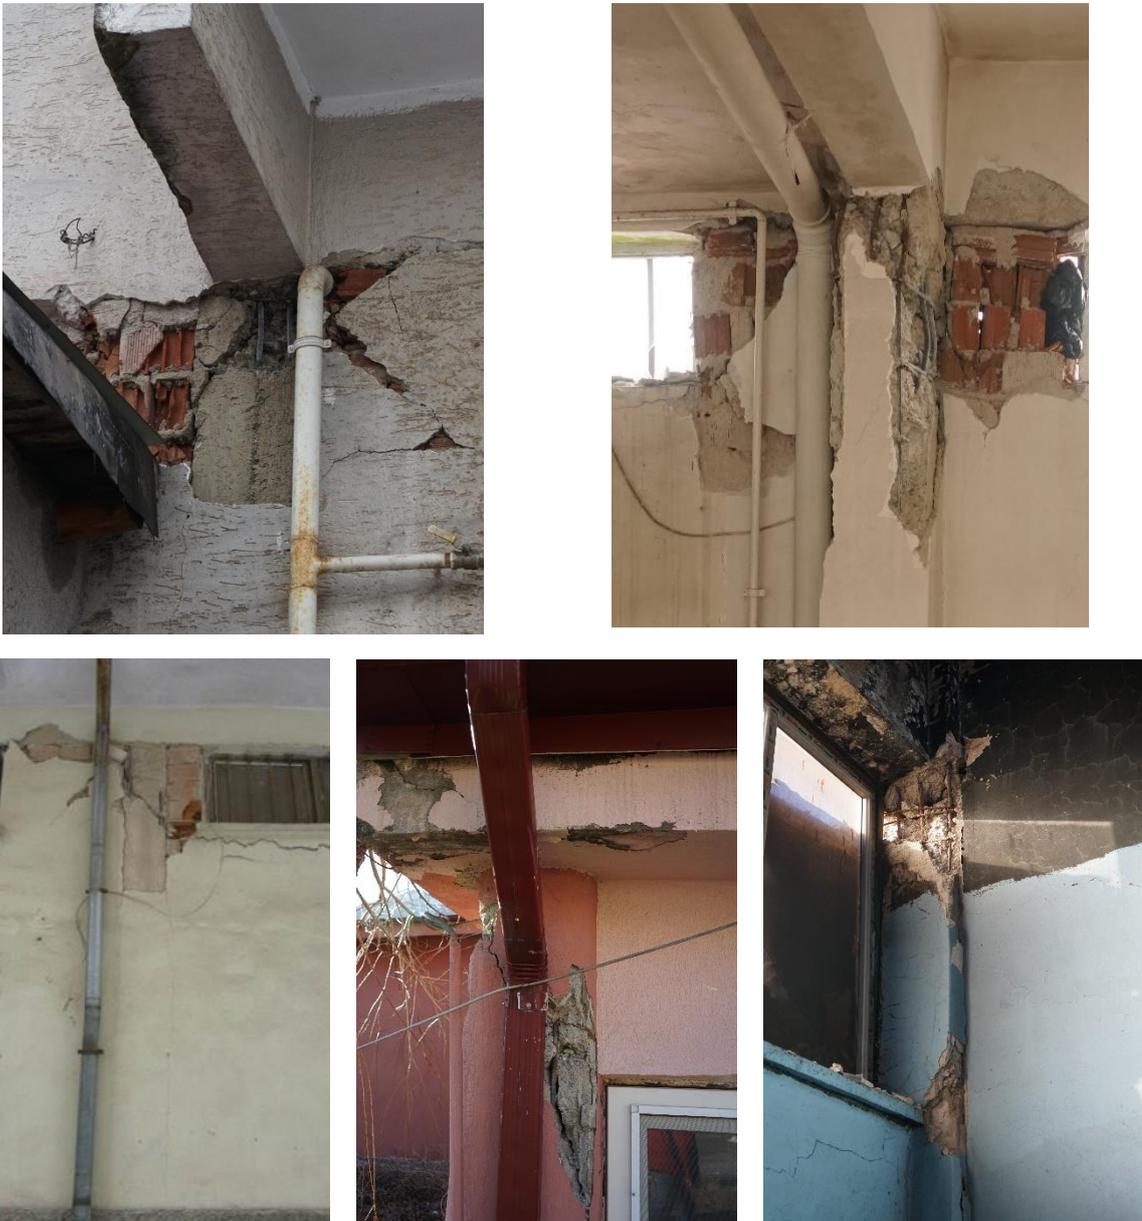
Fig. 1.20. Captive column due to ribbon window (Yurdakul et al. 2021).

The restricted column lateral displacement can also reduce the column's effective height due to the non-structural components. Such a phenomenon called the captive column is generally observed in columns adjacent to ribbon windows (Fig. 1.20). If the infill wall beneath the ribbon window has sufficient strength and stiffness to restrict the lateral displacement of the column, the effective height of the column is reduced to the height of the ribbon window. Therefore, shear demand on the captive columns increases tremendously as a result of its increased lateral stiffness. When the shear capacity of the captive column is not sufficient to resist the increased shear demands, column shear failure becomes inevitable.

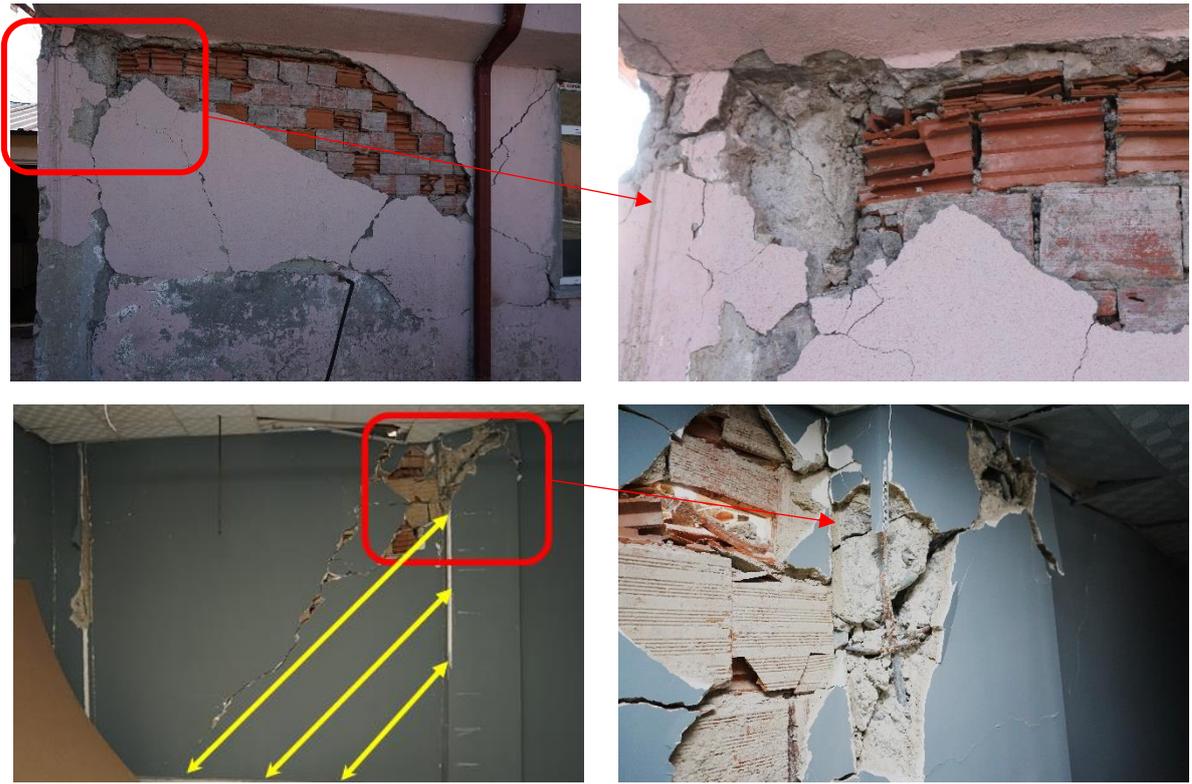
Fig. 1.21. Accidental captive column (a) Elazığ 2020 earthquake, Turkey (Yurdakul et al. 2021) (b) İzmir Seferihisar 2020 earthquake, Turkey (Photo Credit: Özgür Avşar).

The brittle shear damage can be observed in some of the columns interacting with the infill wall. The damage pattern in the column is formed with the same phenomenon in captive or short column damage (i.e., brittle-type shear damage). However, the frames of such columns have masonry infill walls without any openings. The shear damage at columns similar to the short or captive column damage can be seen in Fig. 1.21a and b. Although the captive columns are not expected for columns of frames having infill walls without openings, severe shear cracks were observed as in the cases shown in Fig. 1.21a and b. The corner region of the infill walls crushes due to the excessive axial load developed in the diagonal struts, while the lower parts of the infill wall below the corner region are intact. The upper part of the column, which is in contact with the corner region of the infill crushed locally, can displace laterally. On the other hand, the lateral displacement of the rest of the column is restricted by the diagonal struts developed in the lower part of the infill. Reducing the unsupported length of the column increases the shear demand. If the strength of the diagonal strut developed on the infill wall is greater than the shear strength of the column, then the brittle type of column shear failure is very likely, as in the case of captive columns. Note that the seismic response of the corresponding frames is affected by the material and geometric characteristics of the infill walls and columns. Therefore, in RC buildings with low-strength concrete, reinforcement with improper detailing, and infills with good quality (strength of infill units, mortar, and plaster is good), accidental captive column damage is highly probable.

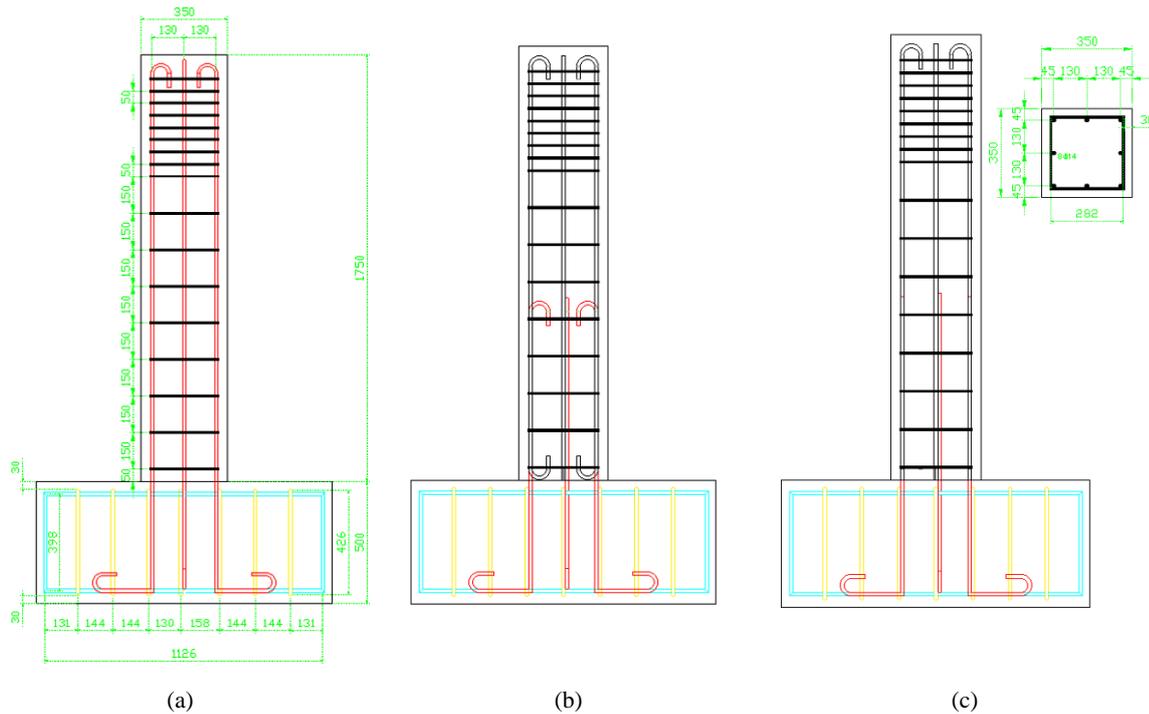
Fig. 2.1. Reinforcement scheme (a) continuous without lap-splice length (b) confirming configuration with hooks (c) non-conforming configuration without hooks.

Three different reinforcing schemes are used (Fig. 2.1a-c). The first group of columns is constructed with continuous longitudinal bars without lap-splice length (Fig. 2.1a). The second group refers to confirming configuration with sufficient lap-splice length and hooks at the ends of the plain reinforcing steel (Fig. 2.1b). The third reinforcing scheme is a non-conforming configuration without hooks (Fig. 2.1c). Note that the continuous reinforcing steel without lap-splice (Fig. 2.1a) does not represent the actual detailing configuration; in turn, the theoretical considerations assume a perfect connection at a lap-splice distance. Those are also summarized in Table 2.2.

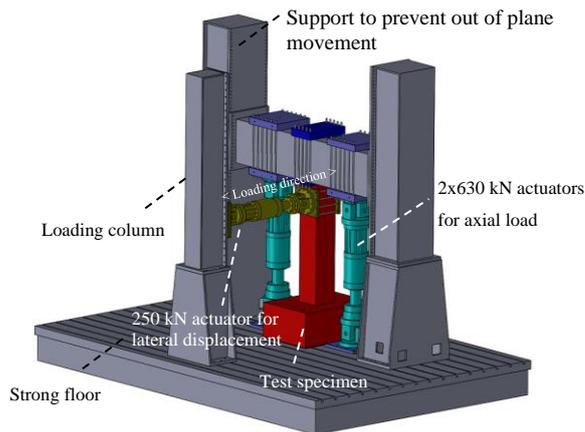
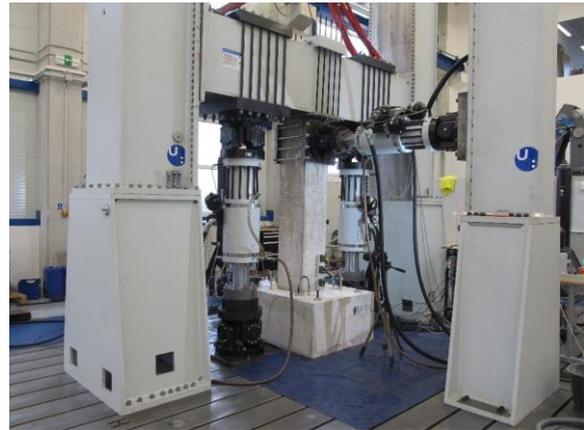
Fig. 2.2. Test setup.

In the test, the cantilever column with a total height of 1.75 m (2.25 m with footing) is positioned vertically and fixed to a strong floor. Two actuators with a capacity of 630 kN, at which constant axial load is applied, are fixed to the beam of the loading frame. The lateral displacement with increasing amplitude is applied by the actuator with a capacity of 250 kN, which is fixed to the loading column through hinges and rigid steel plates. Moreover, the out-of-plane movement of specimens is restricted by supporting the loading beam laterally (Fig. 2.2).

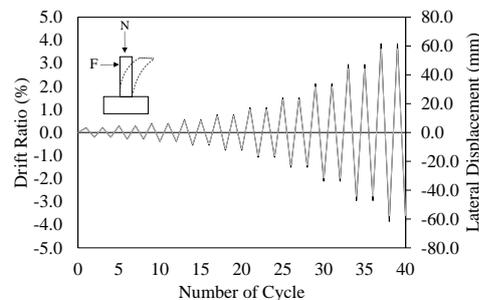
Fig. 2.3. Displacement history.

The intensive level of the damage is simulated by the imposed quasi-static cyclic displacement, which is carried out up to specified displacement levels (Fig. 2.3). FEMA 461 (2007) is the guiding document for the displacement protocol, which may be implemented for drift-sensitive structural and nonstructural components. Two cycles with a loading speed of 1 mm/s are imposed in each loading amplitude not to induce any dynamic effects during the testing. It should be emphasized that the notified drift ratio represents the ratio of measured lateral displacement to column height (i.e., 1.50 m). The displacement pushing the column tip represents the positive loading direction, while the negative loading direction is achieved when pulling the specimen.

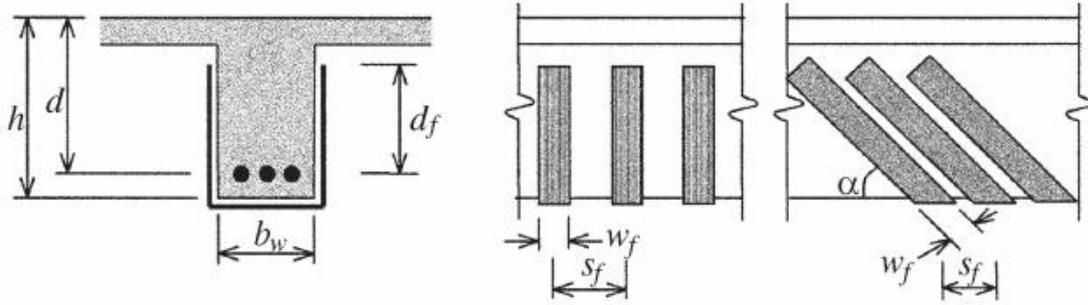
Fig. 2.5. Illustration of the dimensional variables used in shear-strengthening calculations for repair, retrofit or strengthening using FRP laminates (figure from ACI 440.2R-17 (2017)).

The other variables are defined in the previous section, while some are also visually presented in Fig. 2.5.

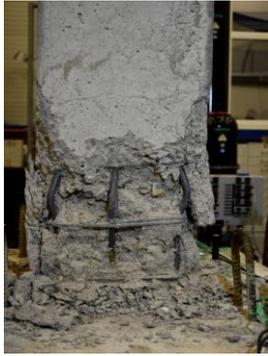
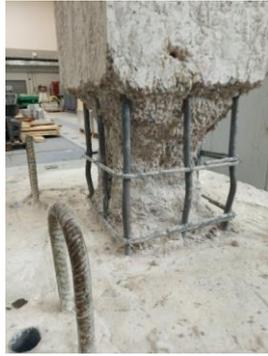
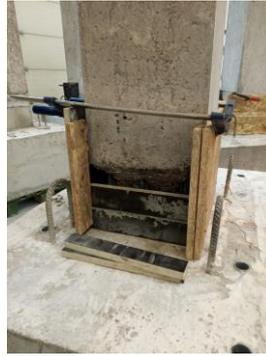
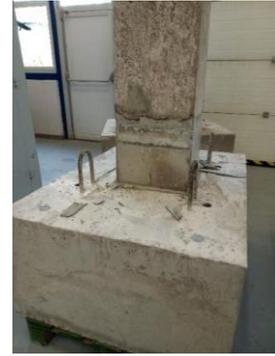
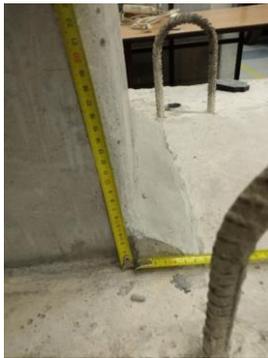
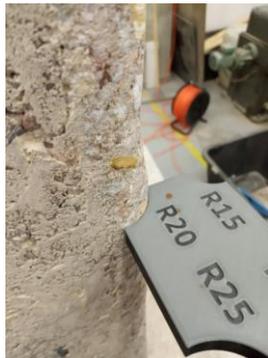
Step 1-Unloading the specimen from test-setup

Step 2-Removing the loose concrete

Step 3-Formwork for repair mortar

Step 4-Applied repair mortar

Step 5-Rounding column-foundation interface

Step 6-Rounding sharp corners on column

Fig. 2.6. Repair of RC column by CFRP.

MAPEI company supports the current research program by providing CFRP material and passive technical support. Therefore, the MAPEI CFRP and its related products are used. Following the previous chapter, the weight of CFRP per  $m^2$  is dimensioned. 2 layers of 300  $g/m^2$  CFRP in the longitudinal direction and 1 layer of 300  $g/m^2$  CFRP in the transverse direction is used. The longitudinal CFRP is used to recover the flexural capacity. The pull-out failure due to extensive slip of the plain round bar is prevented as well. The part of the longitudinal CFRP layers extended to the foundation is anchored by CFRP fan anchors to the foundation. CFRP layers in the lateral direction help to increase shear capacity and displacement ductility with provided confinement pressure. Those also anchor the longitudinal CFRP layers. After finding the required level of CFRP, the step-by-step description of the structural repair is visually presented in [Fig. 2.6](#).

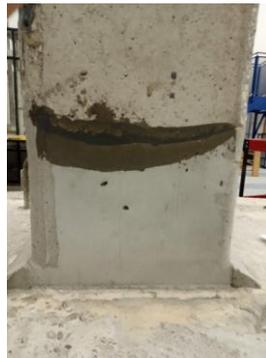
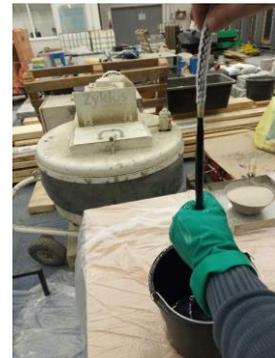
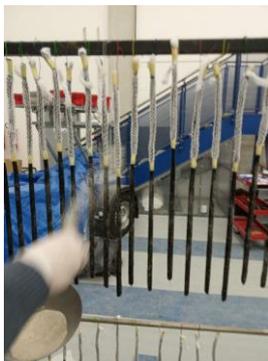
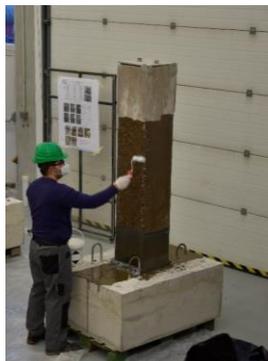
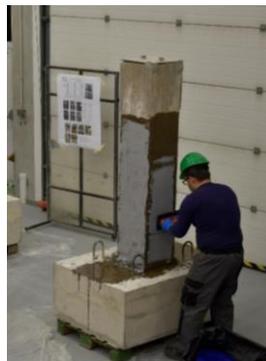
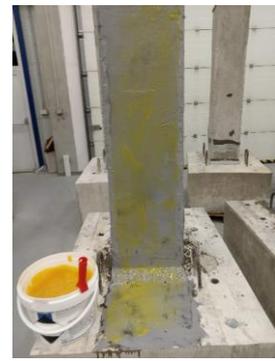
Step 7-Crack filling by epoxy injection

Step 8- Wet epoxy resin application for fiber anchor

Step 9-Sanding fiber anchor

Step 10-Primer application

Step 11-Putty concrete application

Step 12-Dry epoxy resin application

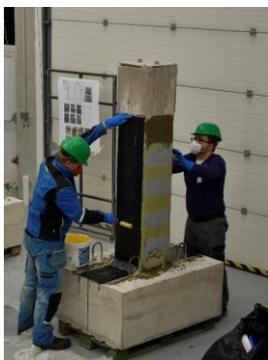
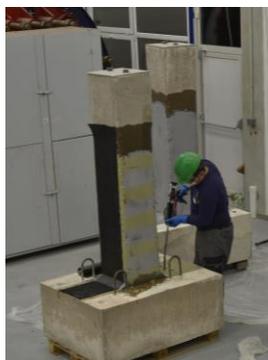
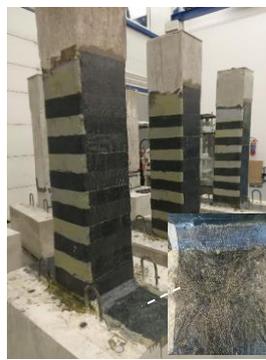
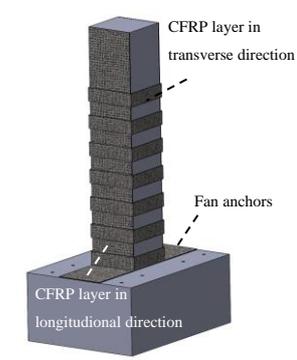
Step 13-CFRP sheet wrapping

Step 14-Chemical anchor for fiber anchors

Step 15-Final product

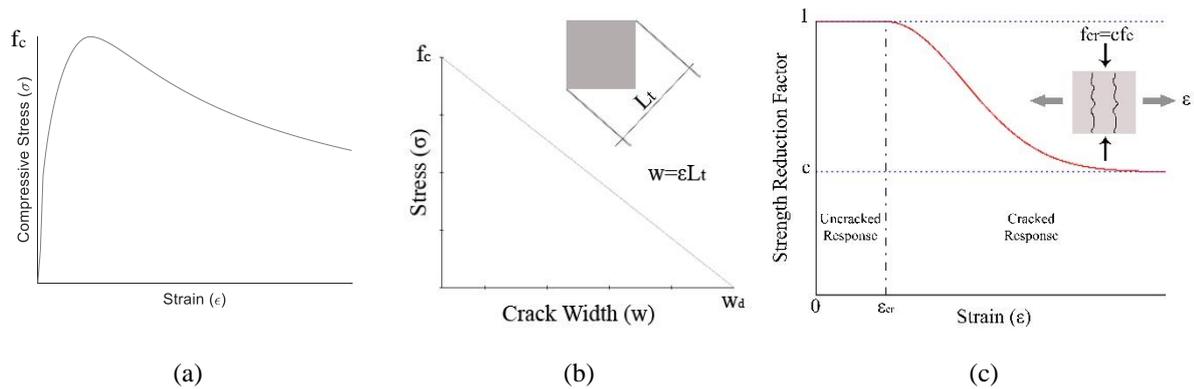
Fig. 3.1. (a) Concrete behavior under compression, (b) Compression softening, (c) Strength reduction in the cracked concrete (ATENA Program Documentation, Part 1 2014).

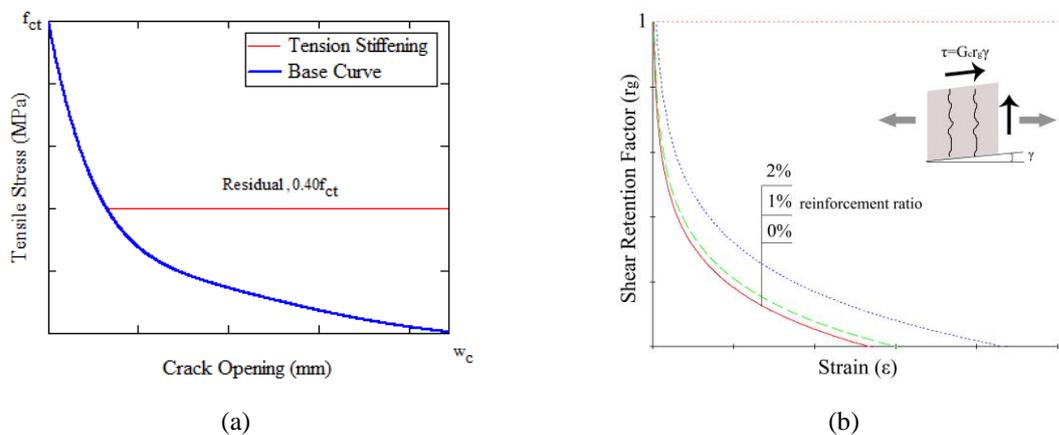
Fig. 3.2. (a) Tension softening and (b) Shear retention factor (ATENA Program Documentation, Part 1 2014).

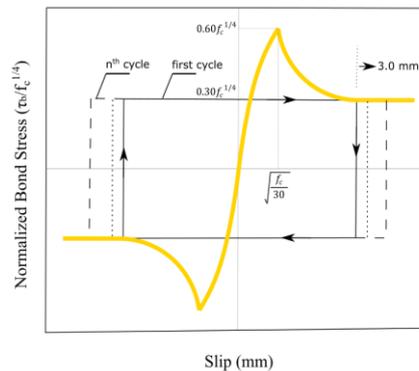
Fig. 3.3. Cyclic bond-slip model for specimens with confinement (Yurdakul et al. (2022)).
