STRUCTURAL REPAIR OF HEAVILY DAMAGED REINFORCED CONCRETE  
COLUMNS: EXPERIMENTAL AND NUMERICAL STUDY

A THESIS SUBMITTED FOR  
THE DEGREE OF ASSOCIATE PROFESSOR

2023

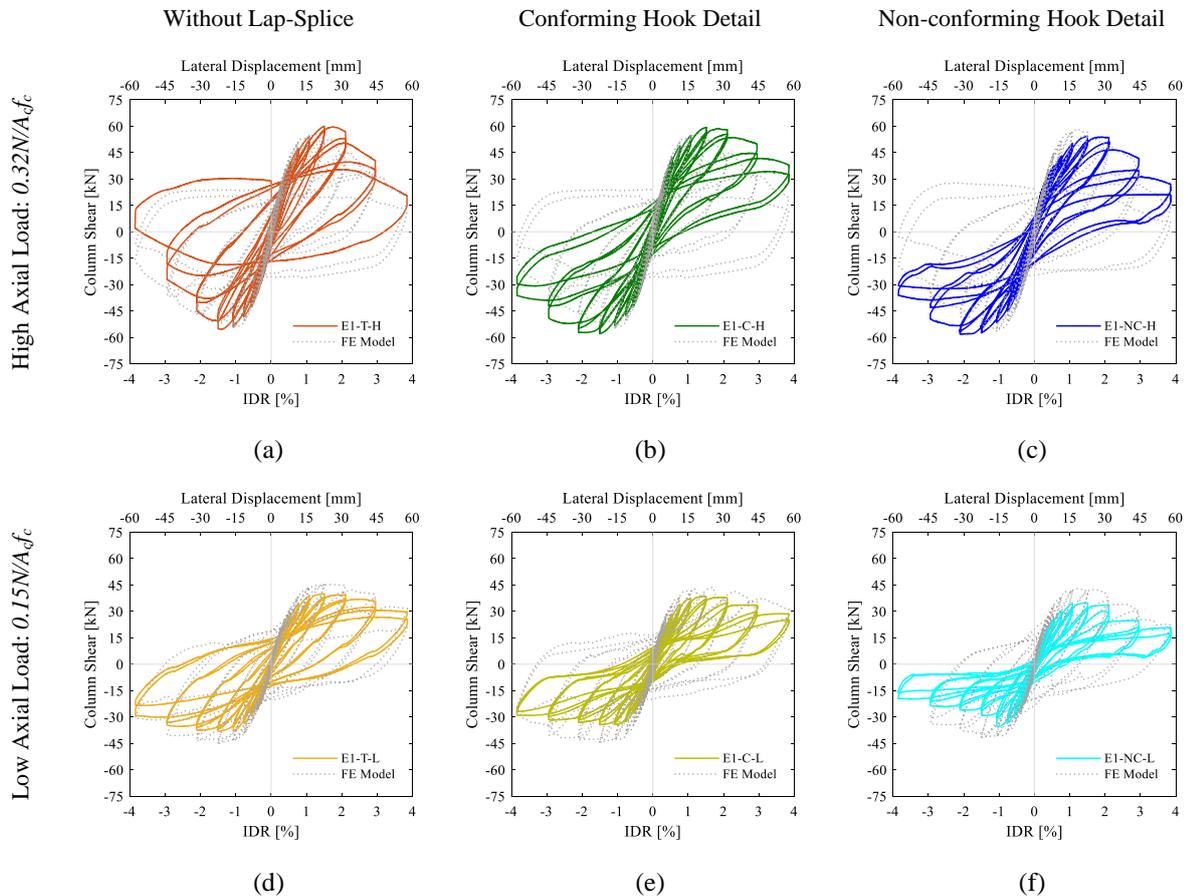
Fig. 4.1. Hysteric response of as-built specimens (a) E1-T-H (b) E1-C-H (c) E1-NC-H (d) E1-T-L (e) E1-C-L (f) E1-NC-L.

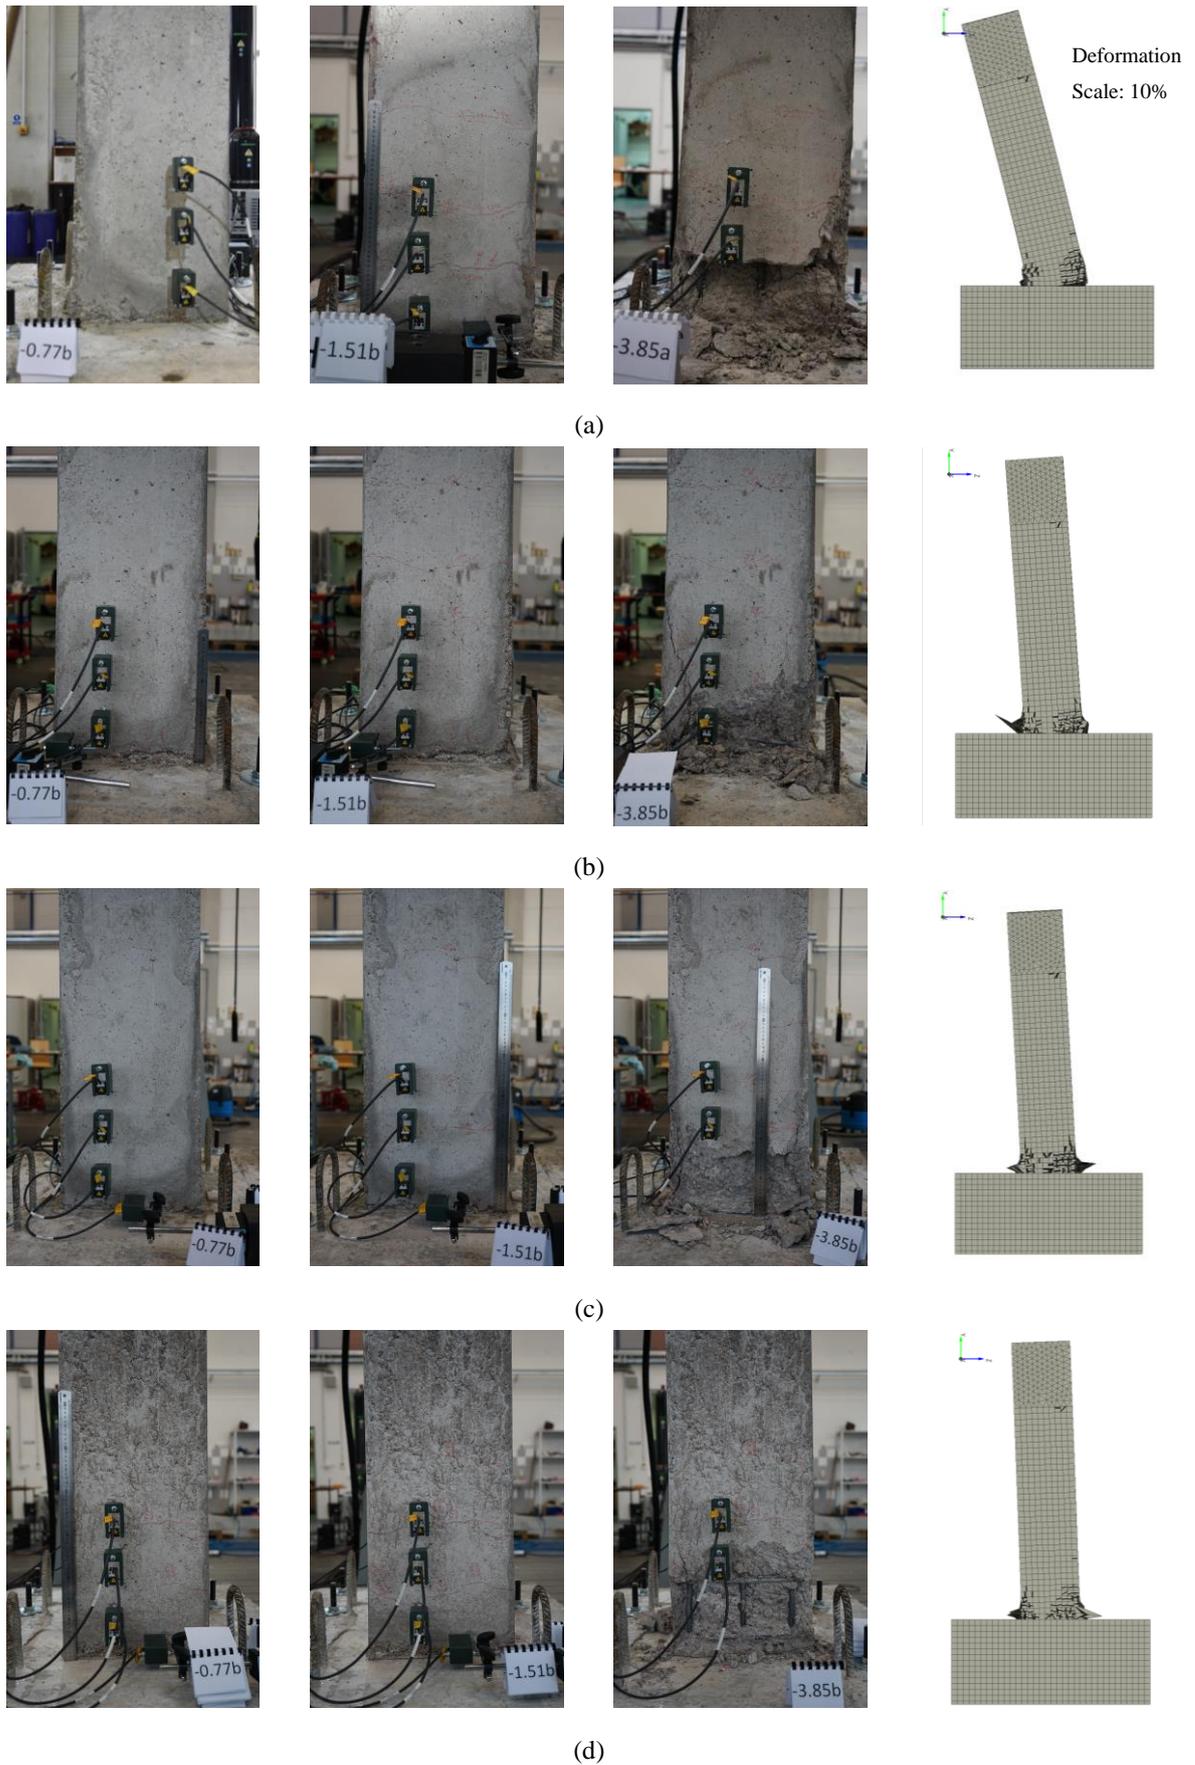
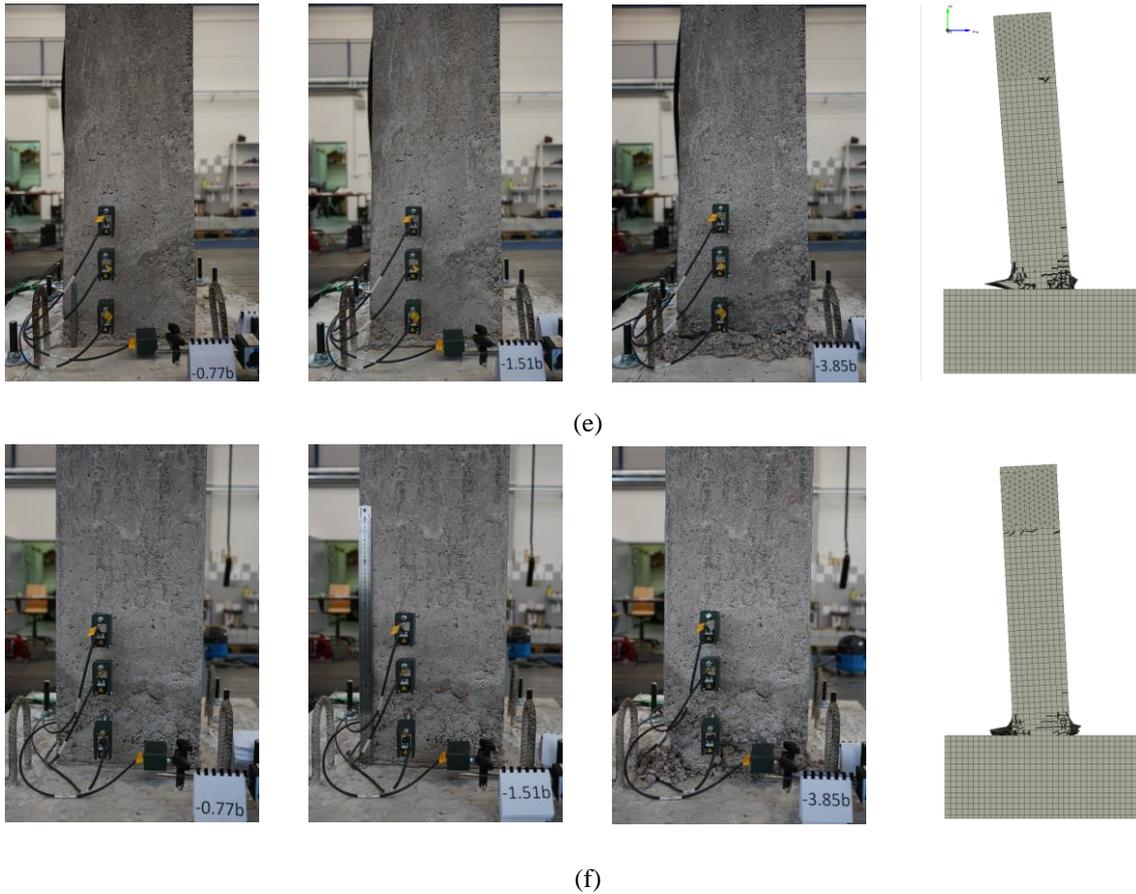
Fig. 4.2. Damage evaluation in as-built specimens (a) E1-T-H (b) E1-C-H (c) E1-NC-H (d) E1-T-L (e) E1-C-L (f) E1-NC-L.

Fig. 4.2 (cont.). Damage evaluation in as-built specimens (a) E1-T-H (b) E1-C-H (c) E1-NC-H (d) E1-T-L (e) E1-C-L (f) E1-NC-L.

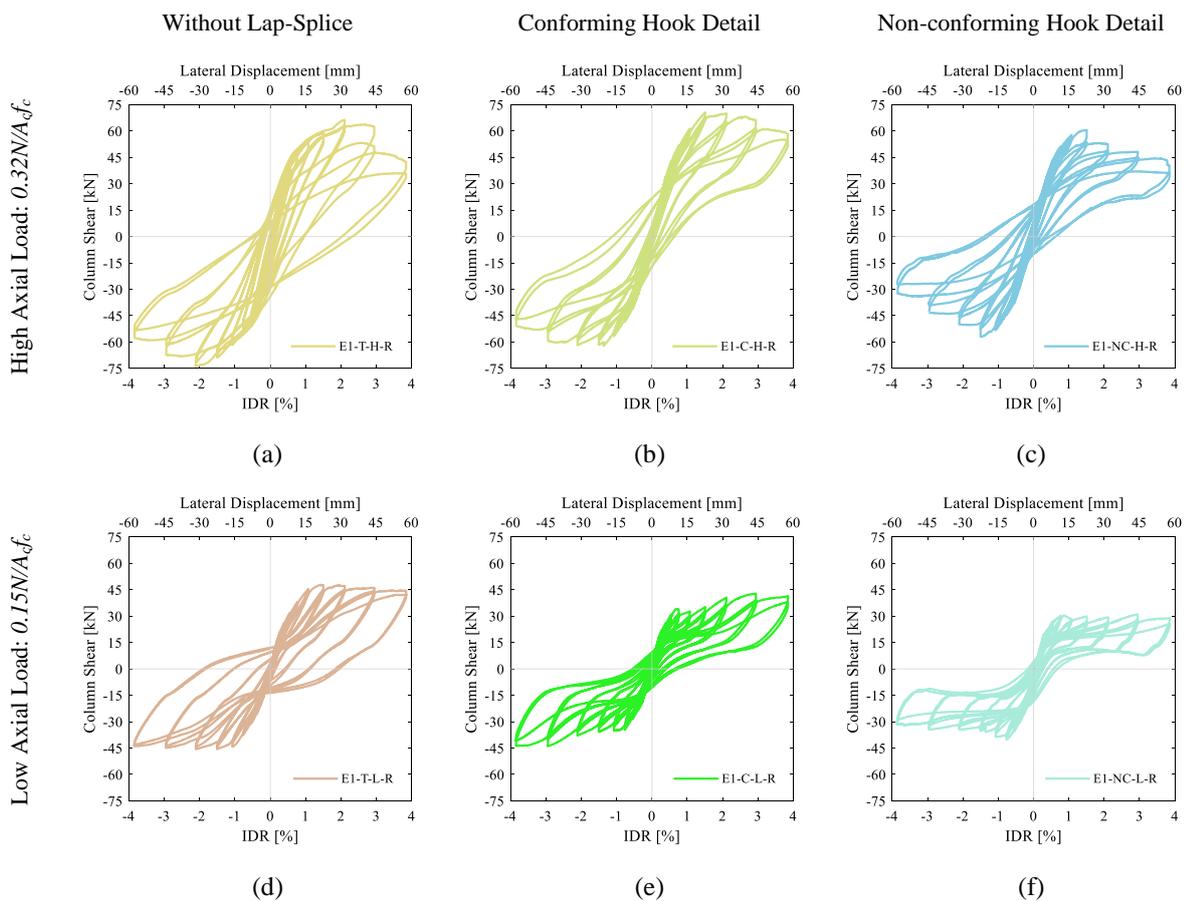
Fig. 4.3. Hysteric response of repaired specimens (a) E1-T-H-R (b) E1-C-H-R (c) E1-NC-H-R (d) E1-T-L-R (e) E1-C-L-R. (f) E1-NC-L-R.

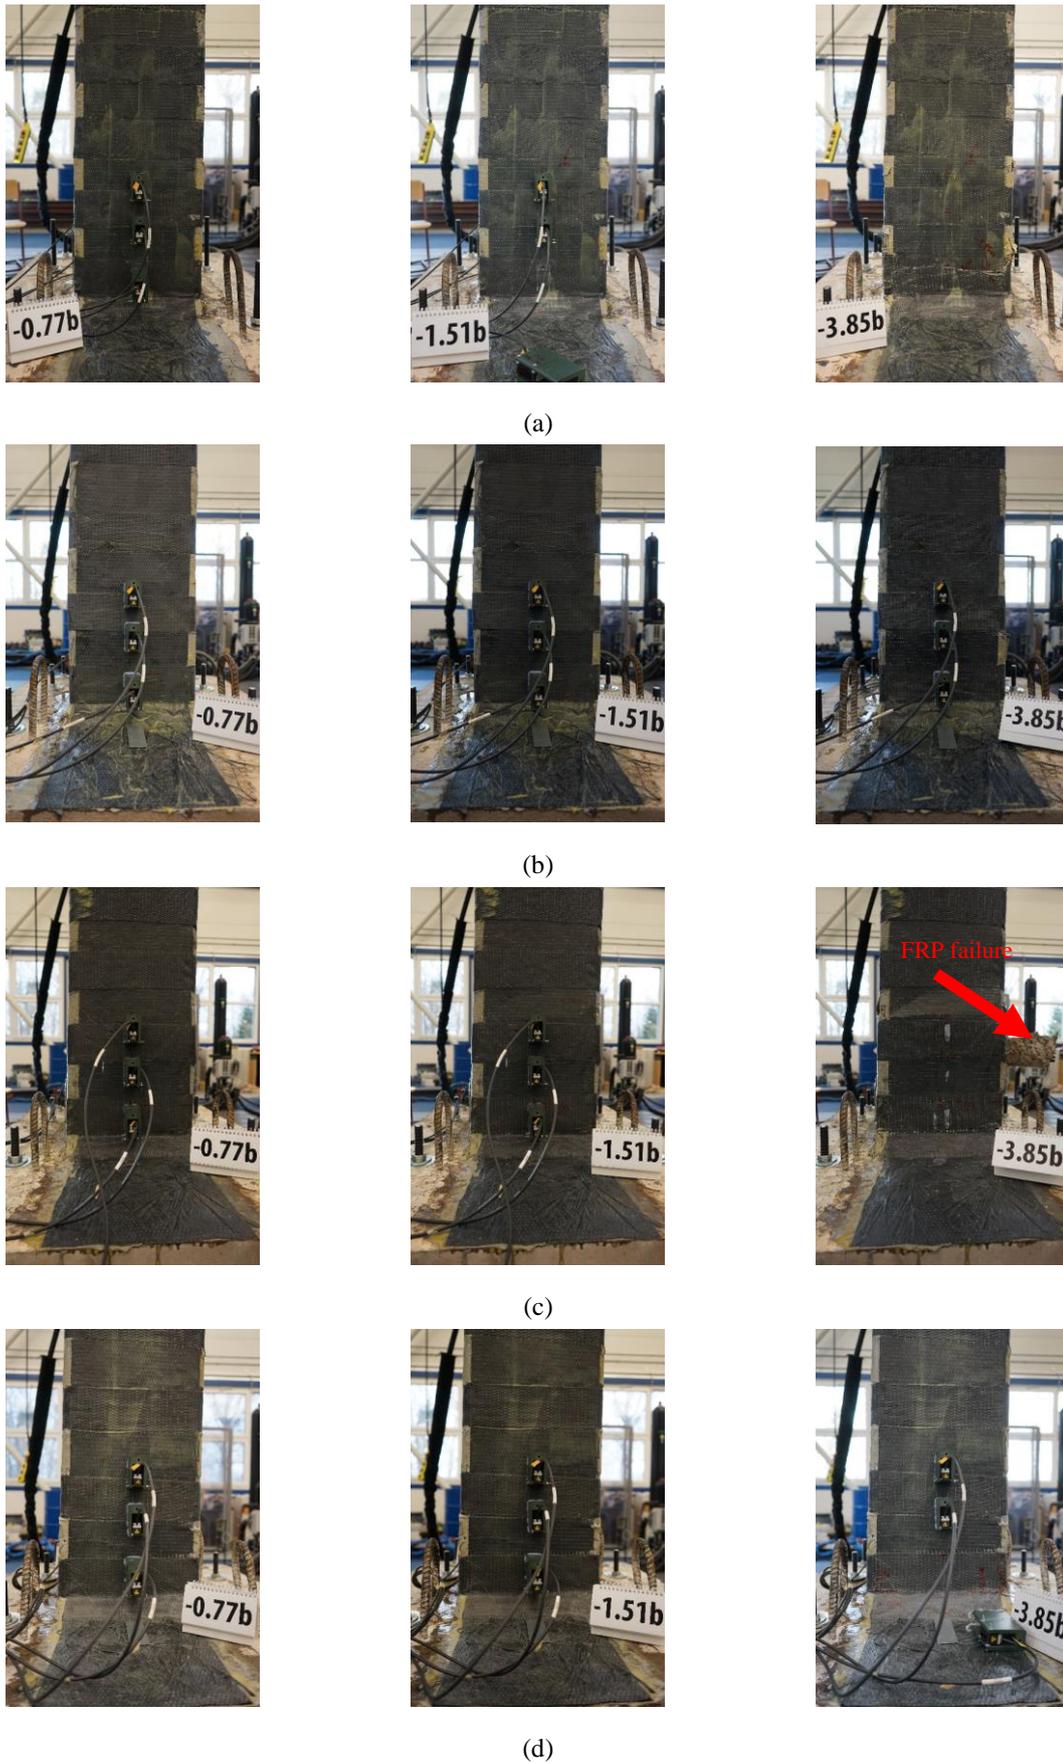
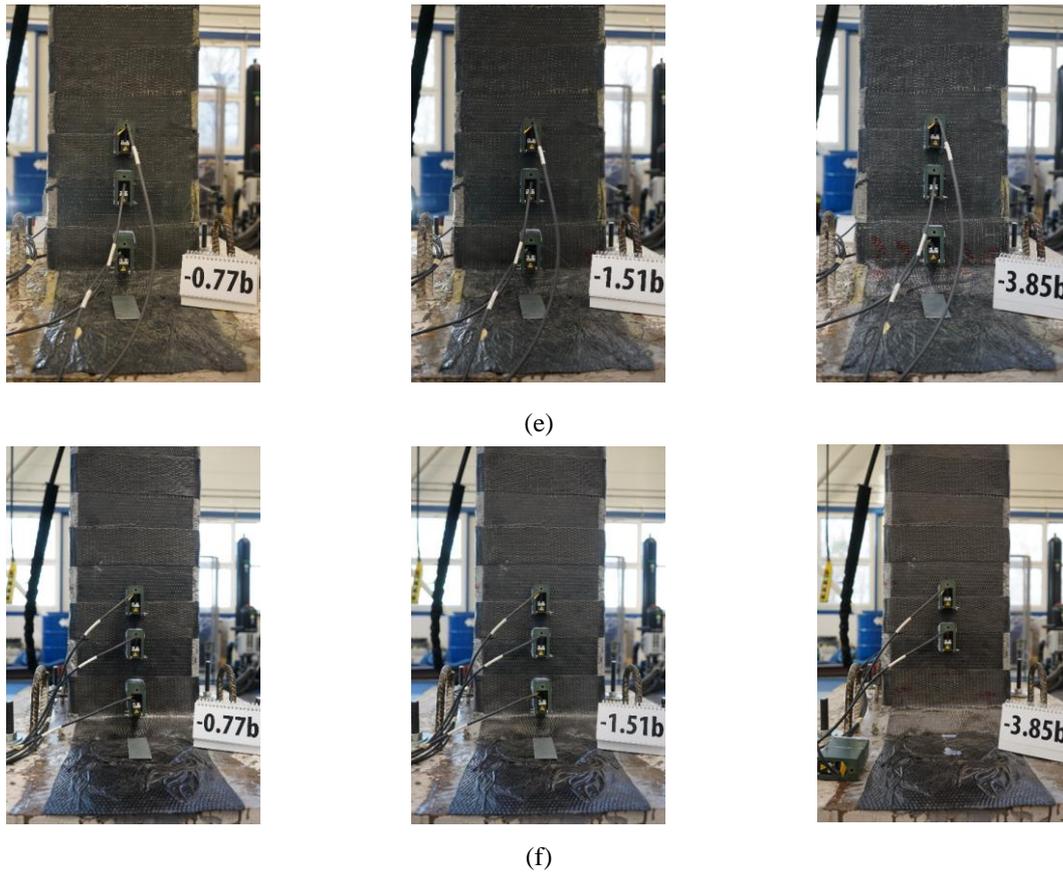
Fig. 4.4. Damage evaluation in repaired specimens (a) E1-T-H-R (b) E1-C-H-R (c) E1-NC-H-R (d) E1-T-L-R (e) E1-C-L-R. (f) E1-NC-L-R.

Fig. 4.4 (cont.). Damage evaluation in repaired specimens (a) E1-T-H-R (b) E1-C-H-R (c) E1-NC-H-R (d) E1-T-L-R (e) E1-C-L-R. (f) E1-NC-L-R.

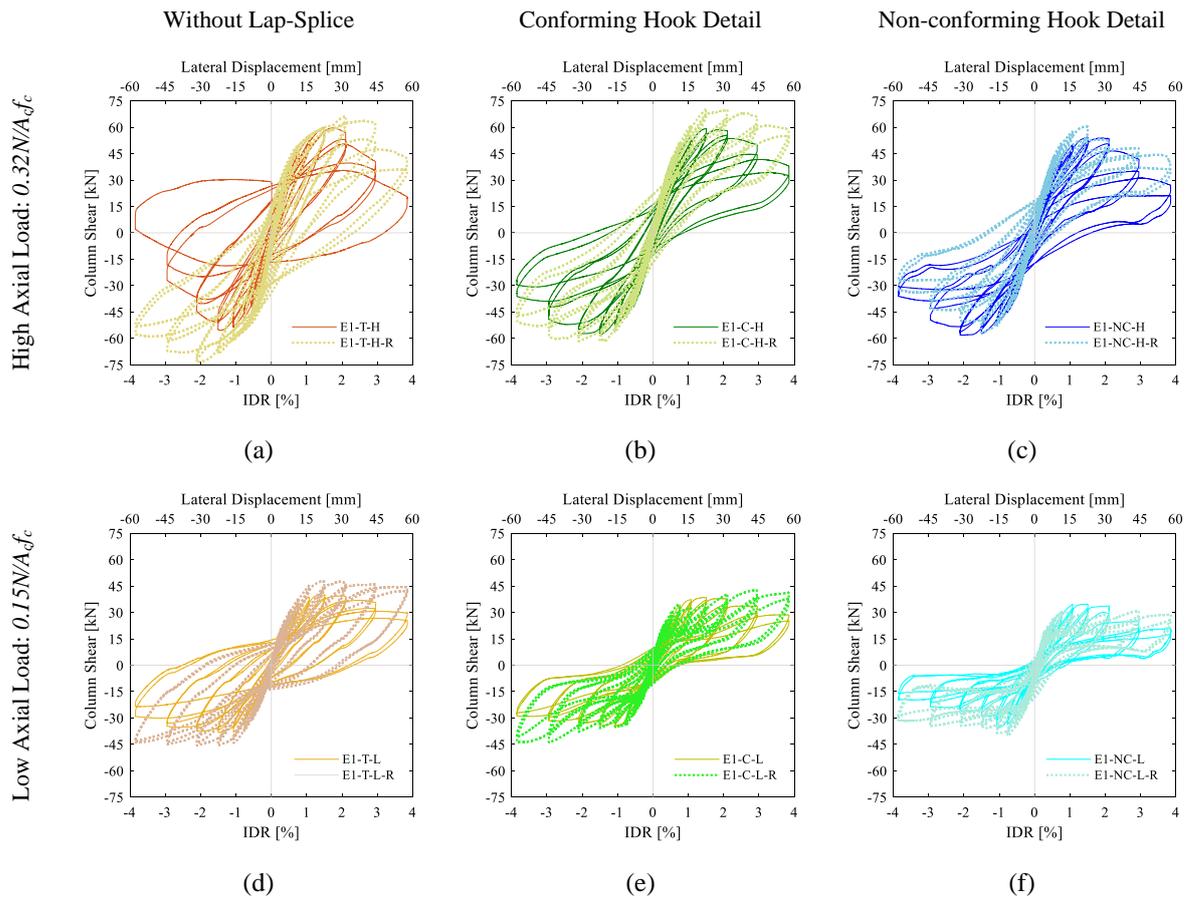
Fig. 4.5. Comparison of hysteretic responses specimen with (a) high axial load and no lap-splice (b) high axial load and conforming hook (c) high axial load and non-conforming hook (d) low axial load and no lap-splice (e) low axial load and conforming hook (f) low axial load and non-conforming hook.

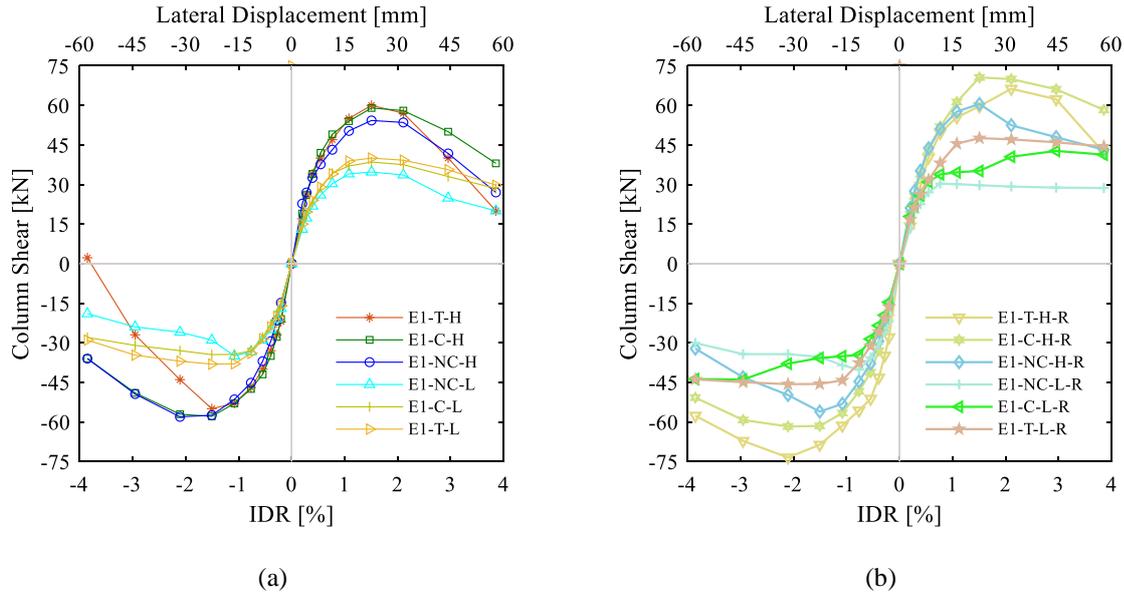
Fig. 4.6. Backbone curves of hysteretic response (a) as-built specimens (b) repaired specimens.

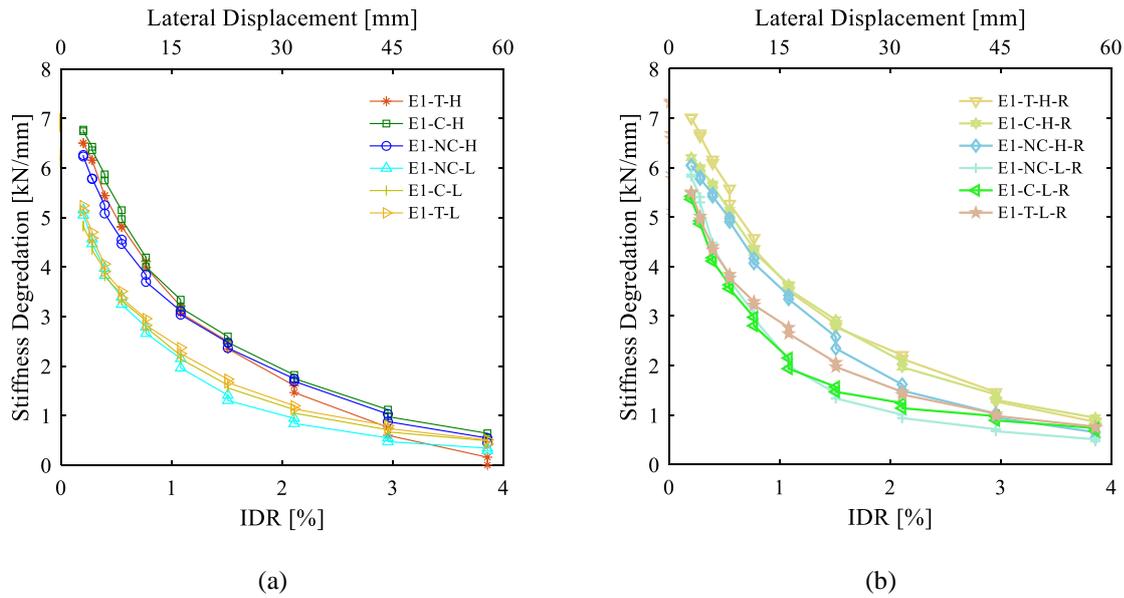
Fig. 4.7. Stiffness degradation (a) as-built specimens (b) repaired specimens.

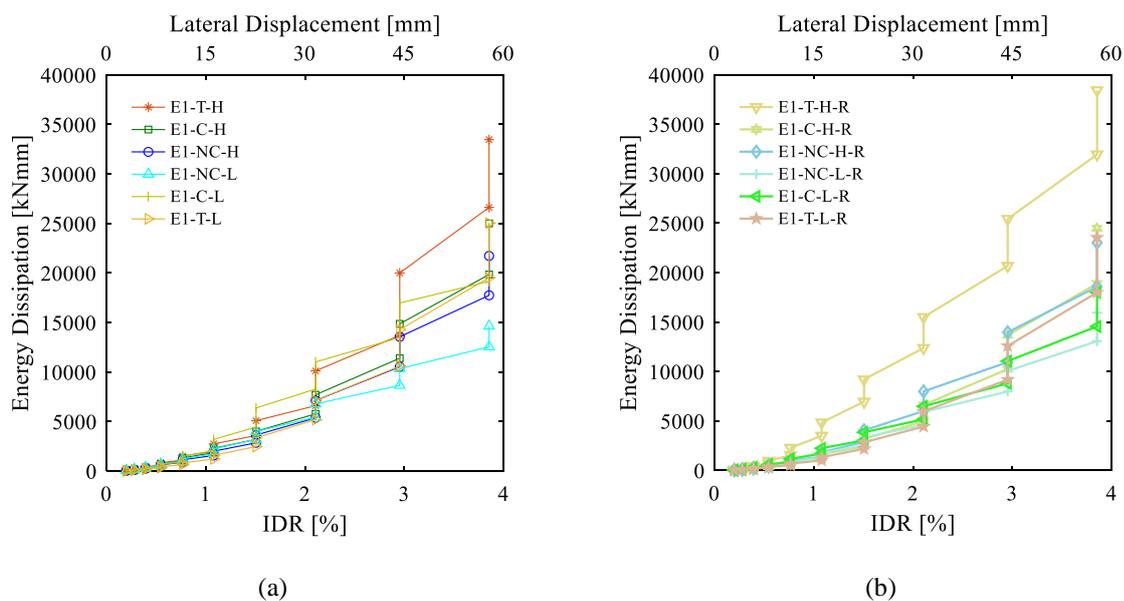
Fig. 4.8. Dissipated energy (a) as-built specimens (b) repaired specimens.

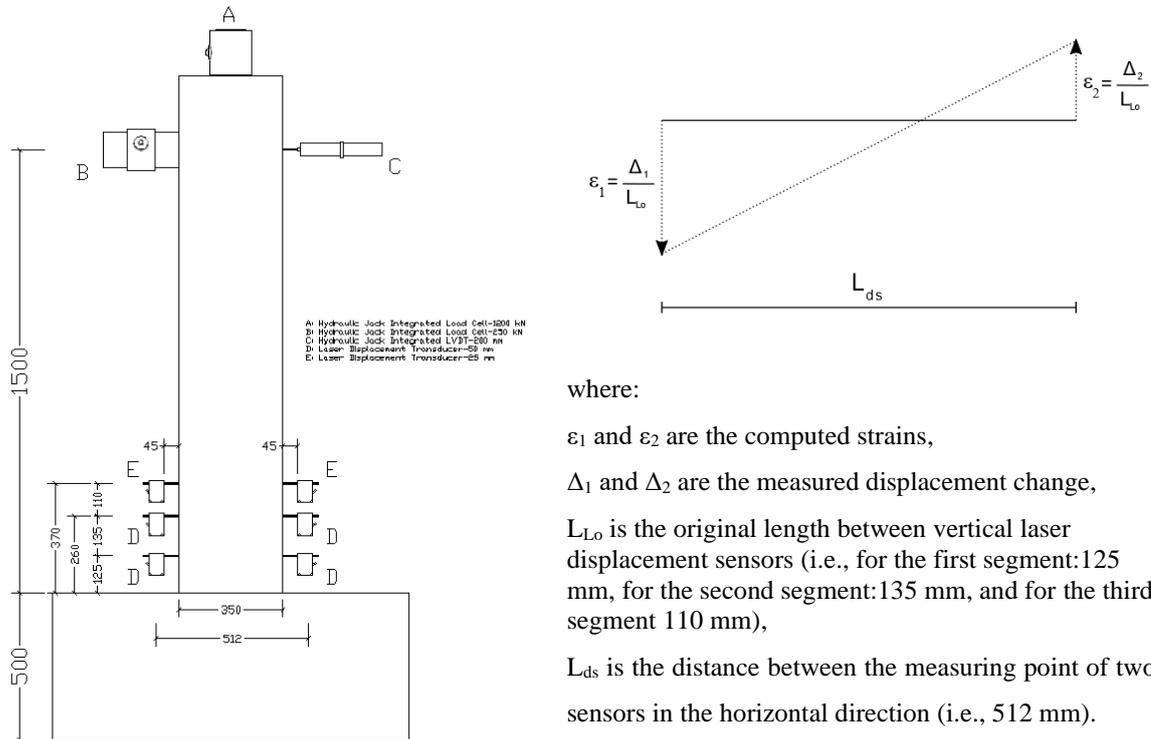
Fig. 4.9. Computation of curvature.

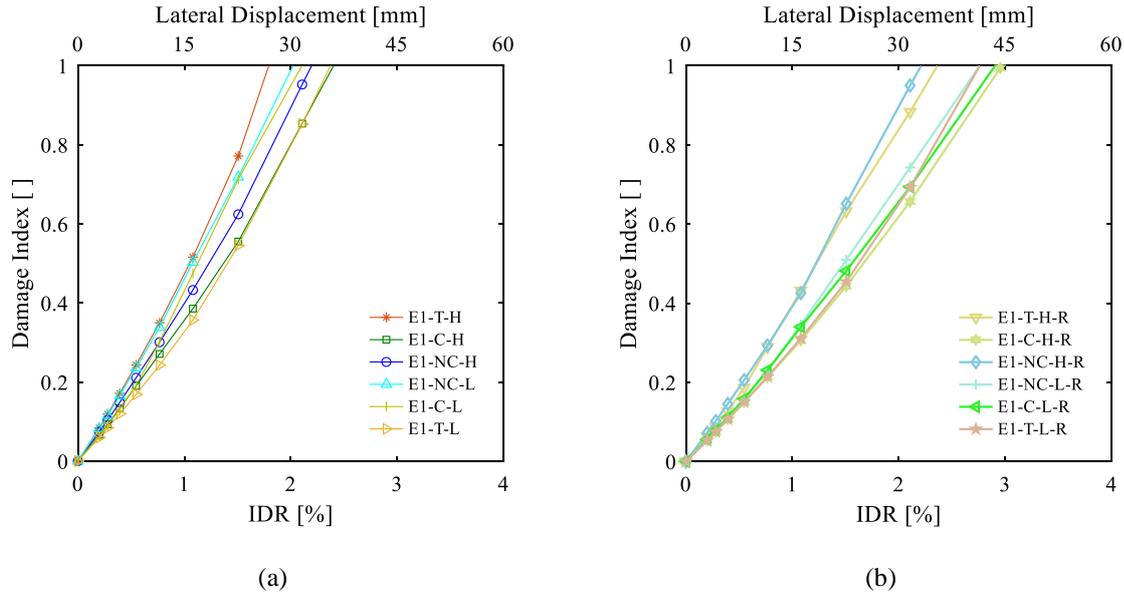
Fig. 4.12. Damage index (a) as-built specimens (b) repaired specimens.

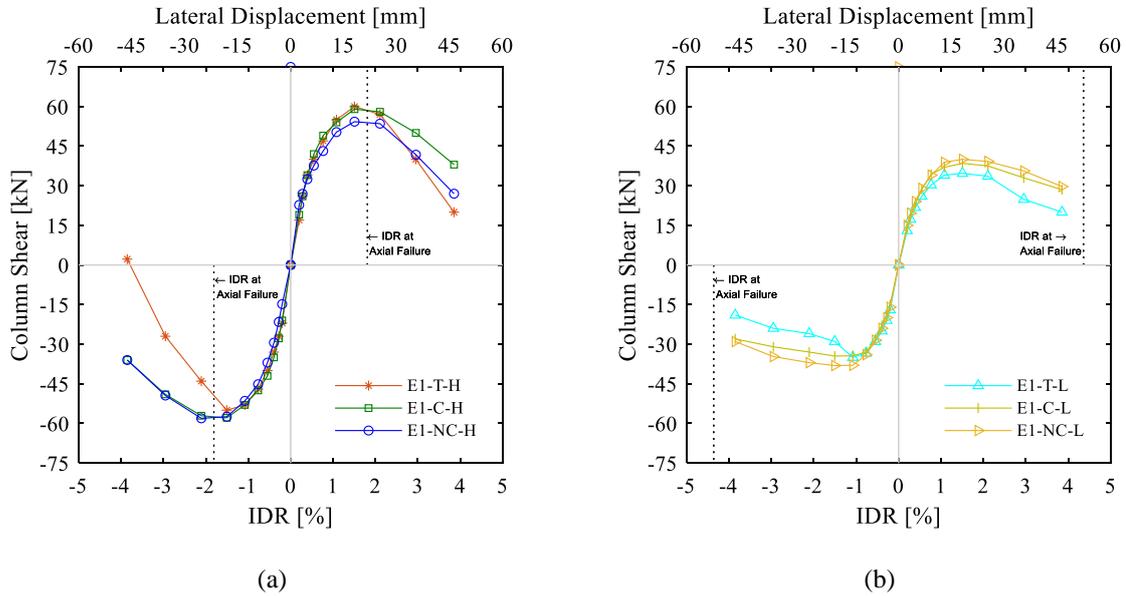
Fig. 4.13. IDR at axial failure (a) as-built specimens with high axial load (b) as-built specimens with low axial load.

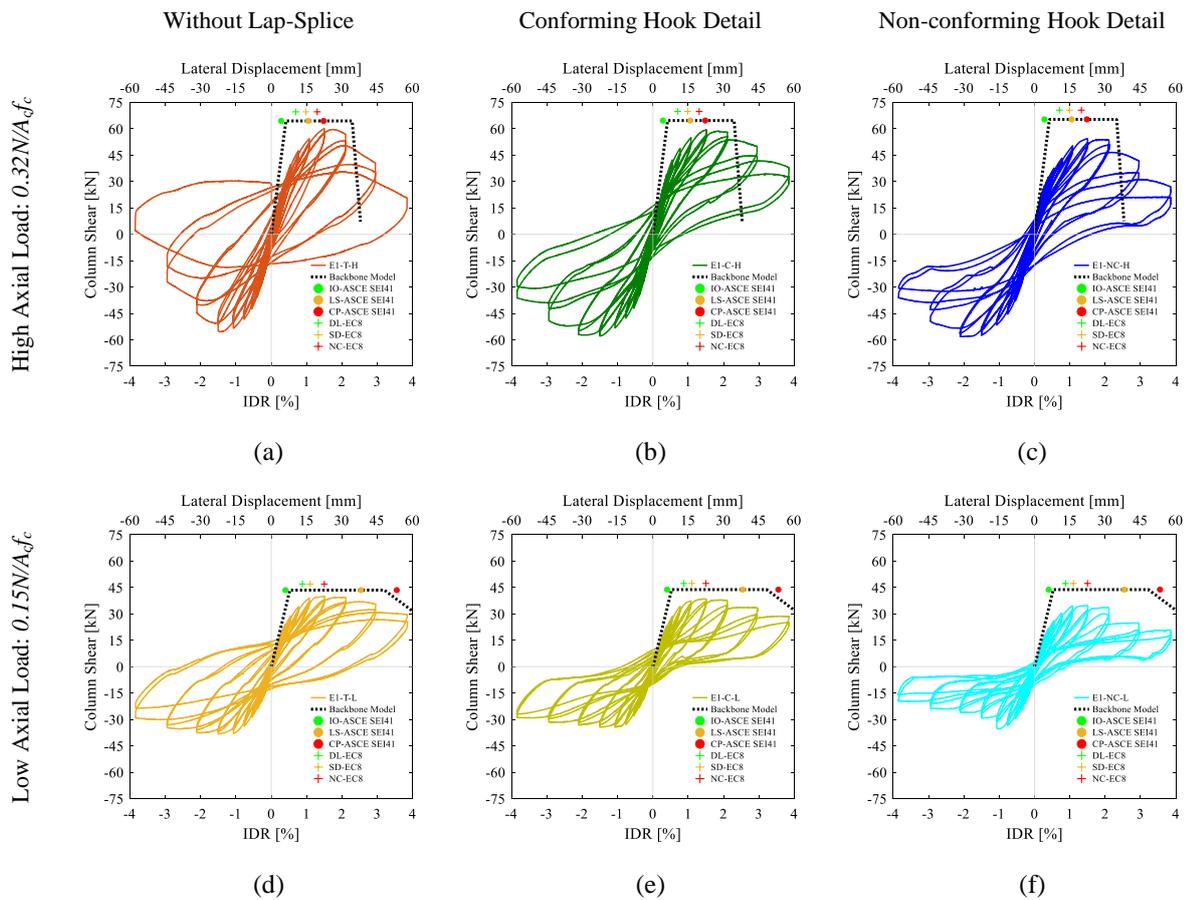
Fig. 4.14. Comparison of ASCE SEI 41 (2017) backbone models with hysteretic responses (a) E1-T-H (b) E1-C-H (c) E1-NC-H (d) E1-T-L (e) E1-C-L (f) E1-NC-L.
